MIDDLE ST. CROIX WATERSHED MANAGEMENT ORGANIZATION

Regular Meeting of the Middle St. Croix Watershed Management Organization

Thursday, August 13th, 2020

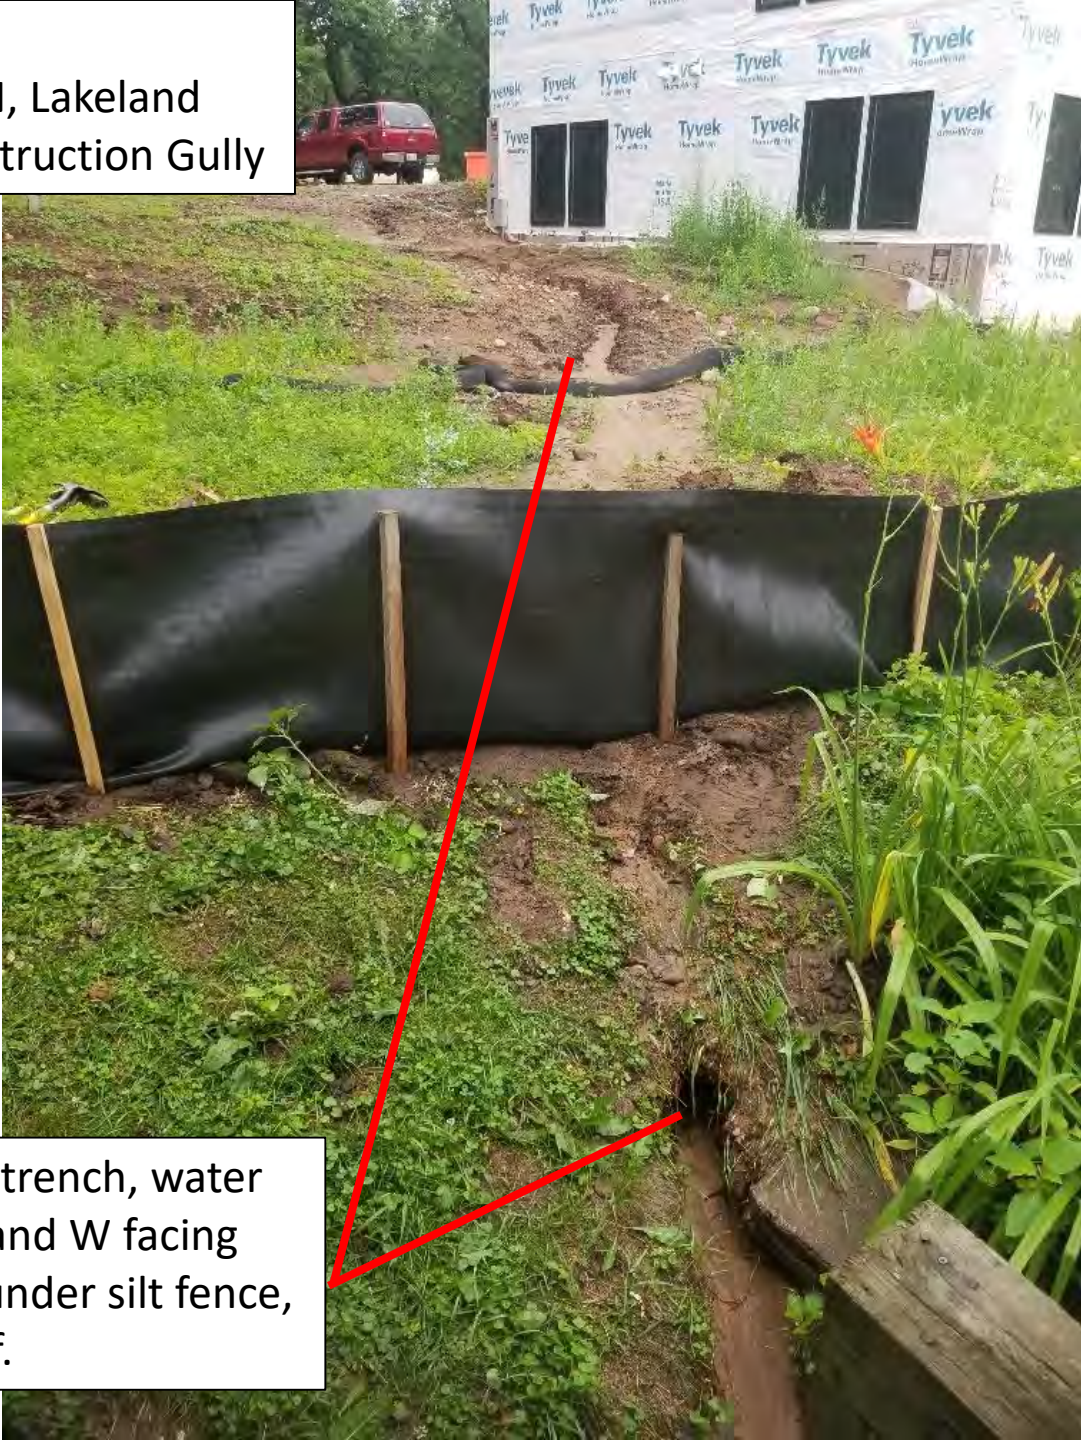
6/30/2020
1635 Rivercrest Rd N, Lakeland
Stordahl Home Construction Gully

8. Additional details: Homeowner Matt Stordahl self-reported the gully to me the day after the rain event. Mr. Stordahl, his builder Adam Novacek, and myself assessed the gully and developed a plan to direct water away from the bluff into a temporary basin that will become a rain garden upon completion of the project. The redundant perimeter controls used prior to this extreme event had been 100% effective at preventing erosion on the bluff, but none of the measures could have been reasonably expected to withstand this event. Water from the south and west facing roofs found a path along a recently dug and re-filled utility line to the existing tram, and followed the depression of the tram support structures to the river, creating the gully. Site disturbance is below threshold for MPCA permit.

Washed out utility trench, water found way from S and W facing roofs into trench, under silt fence, and down the bluff.

the homeowner at 1635 Rivercrest self-reported a blowout event on the bluff behind the house. Water coming off the roof found soft soil from a recently trenched electrical line directed toward a tram system on the bluff, and severely eroded the bluff from the crest to the toe, creating an incision four to eight feet deep. Impact to the St. Croix River was a sediment delta of coarse sand on the beach below the bluff approximately 45 ft x 50 ft, and 2 ft deep. The homeowner had appropriate and well maintained perimeter controls in place before the event, but they could not withstand such intensity. Follow up with the homeowner included immediate construction of a sediment/infiltration basin, redirecting further roof runoff away from the bluff and into the basin, repairing damaged perimeter controls and gullies above the bluff, and plans to repair the incision with geotextile lined riprap. Inspection reports and photos are attached.

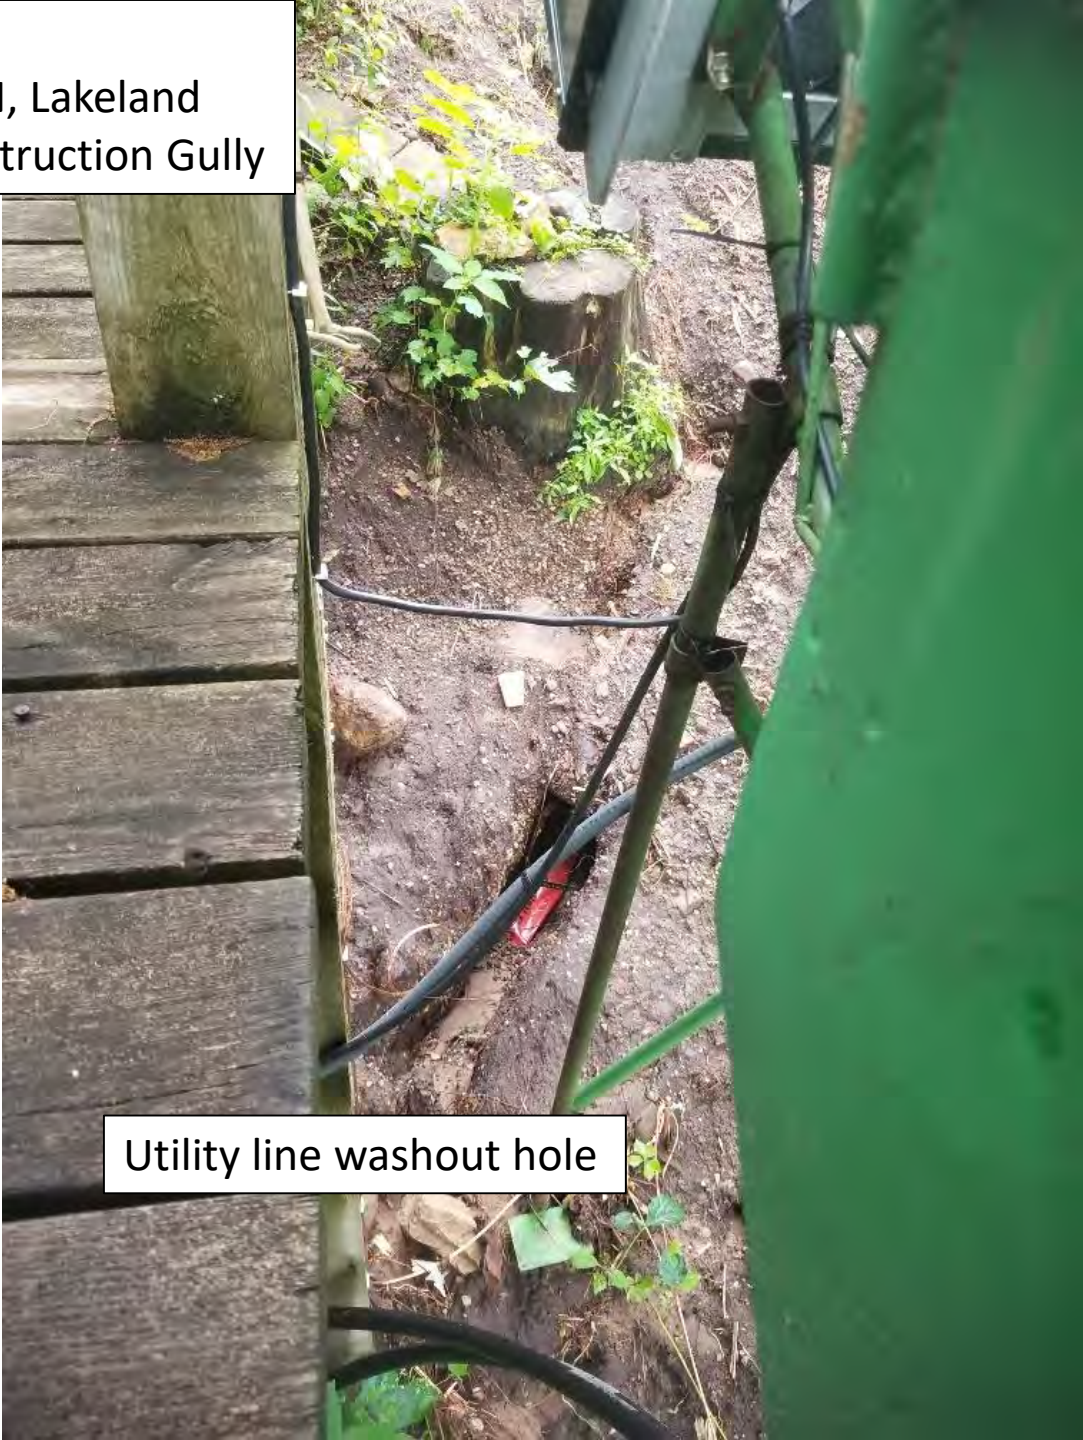
6/30/2020
1635 Rivercrest Rd N, Lakeland
Stordahl Home Construction Gully

Utility line washout hole

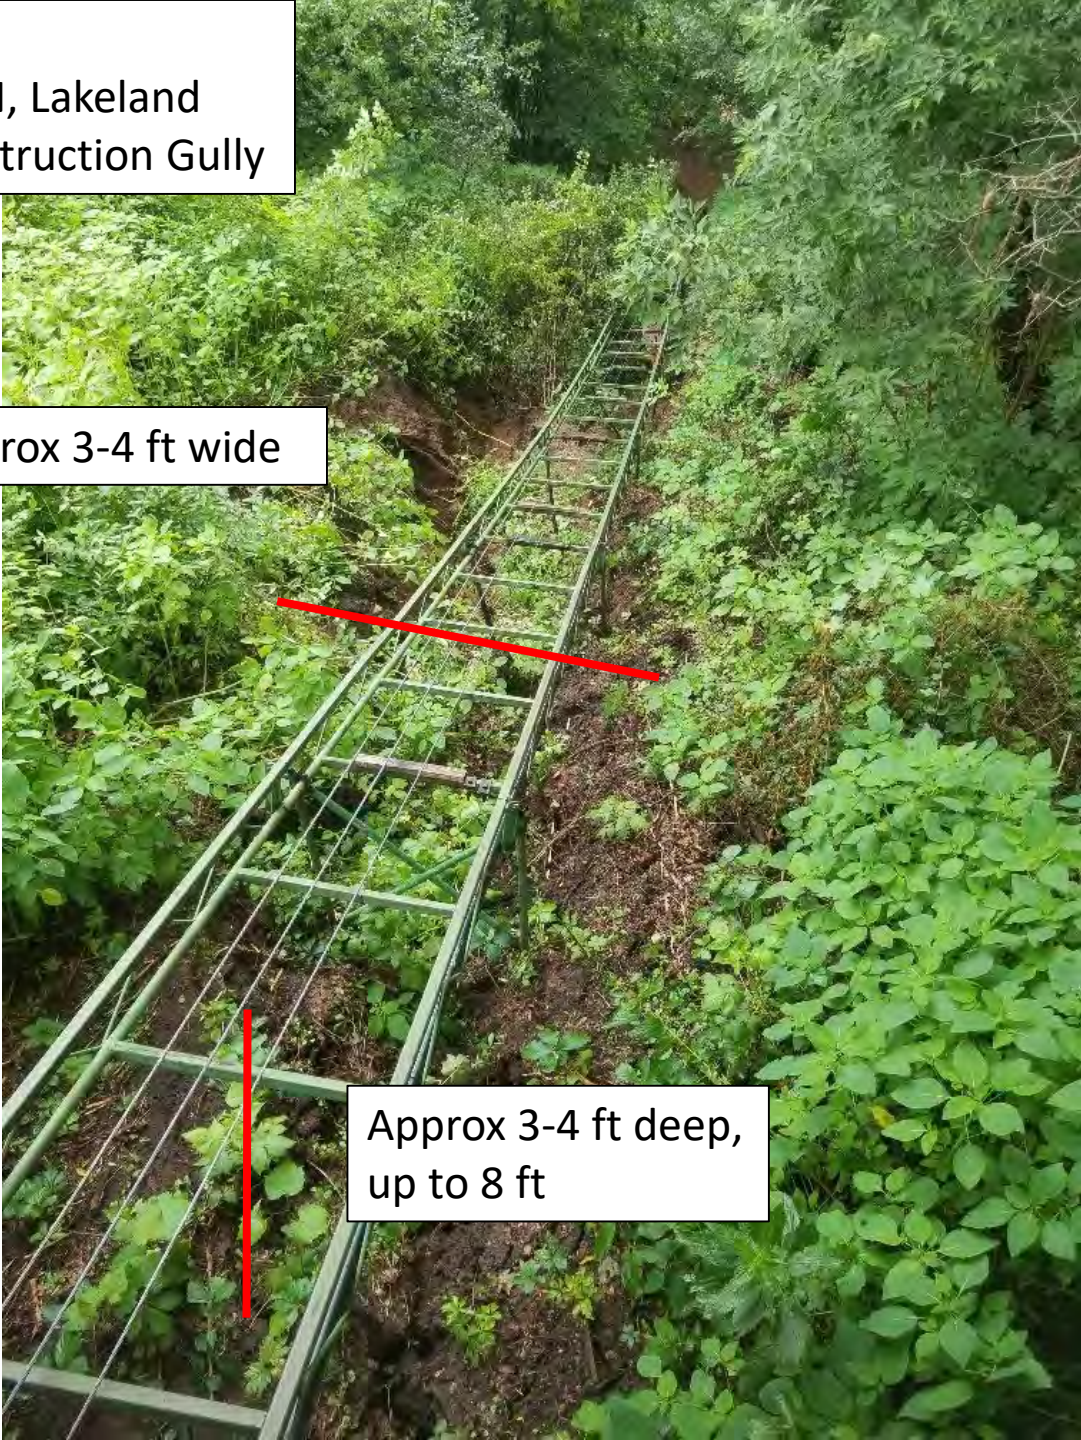
6/30/2020
1635 Rivercrest Rd N, Lakeland
Stordahl Home Construction Gully

Approx 3-4 ft wide

Approx 3-4 ft deep,
up to 8 ft

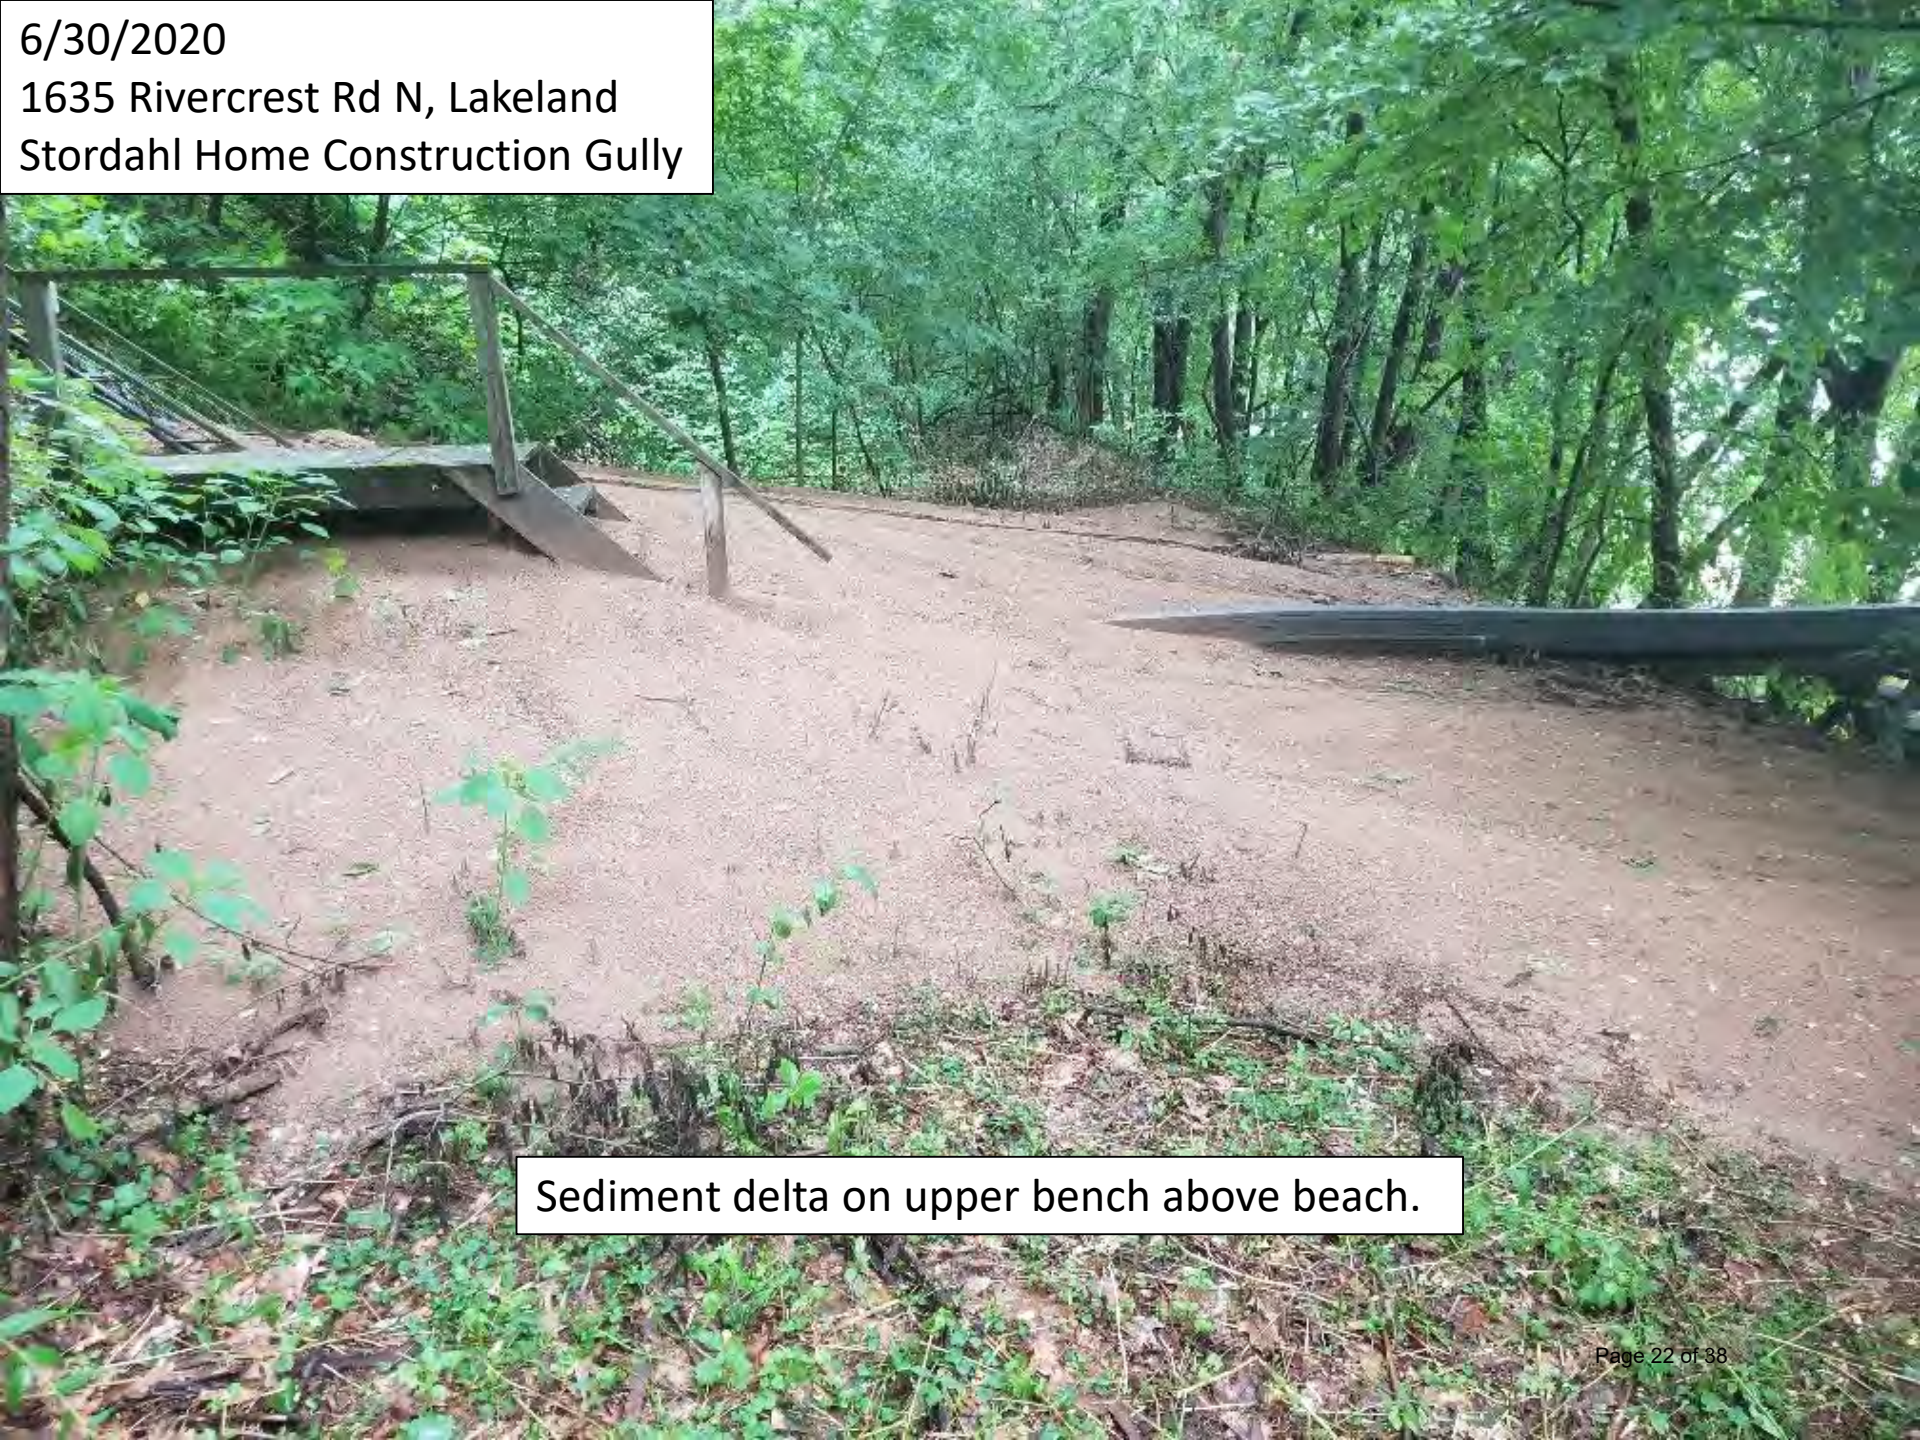
6/30/2020
1635 Rivercrest Rd N, Lakeland
Stordahl Home Construction Gully

Sediment delta on upper bench above beach.

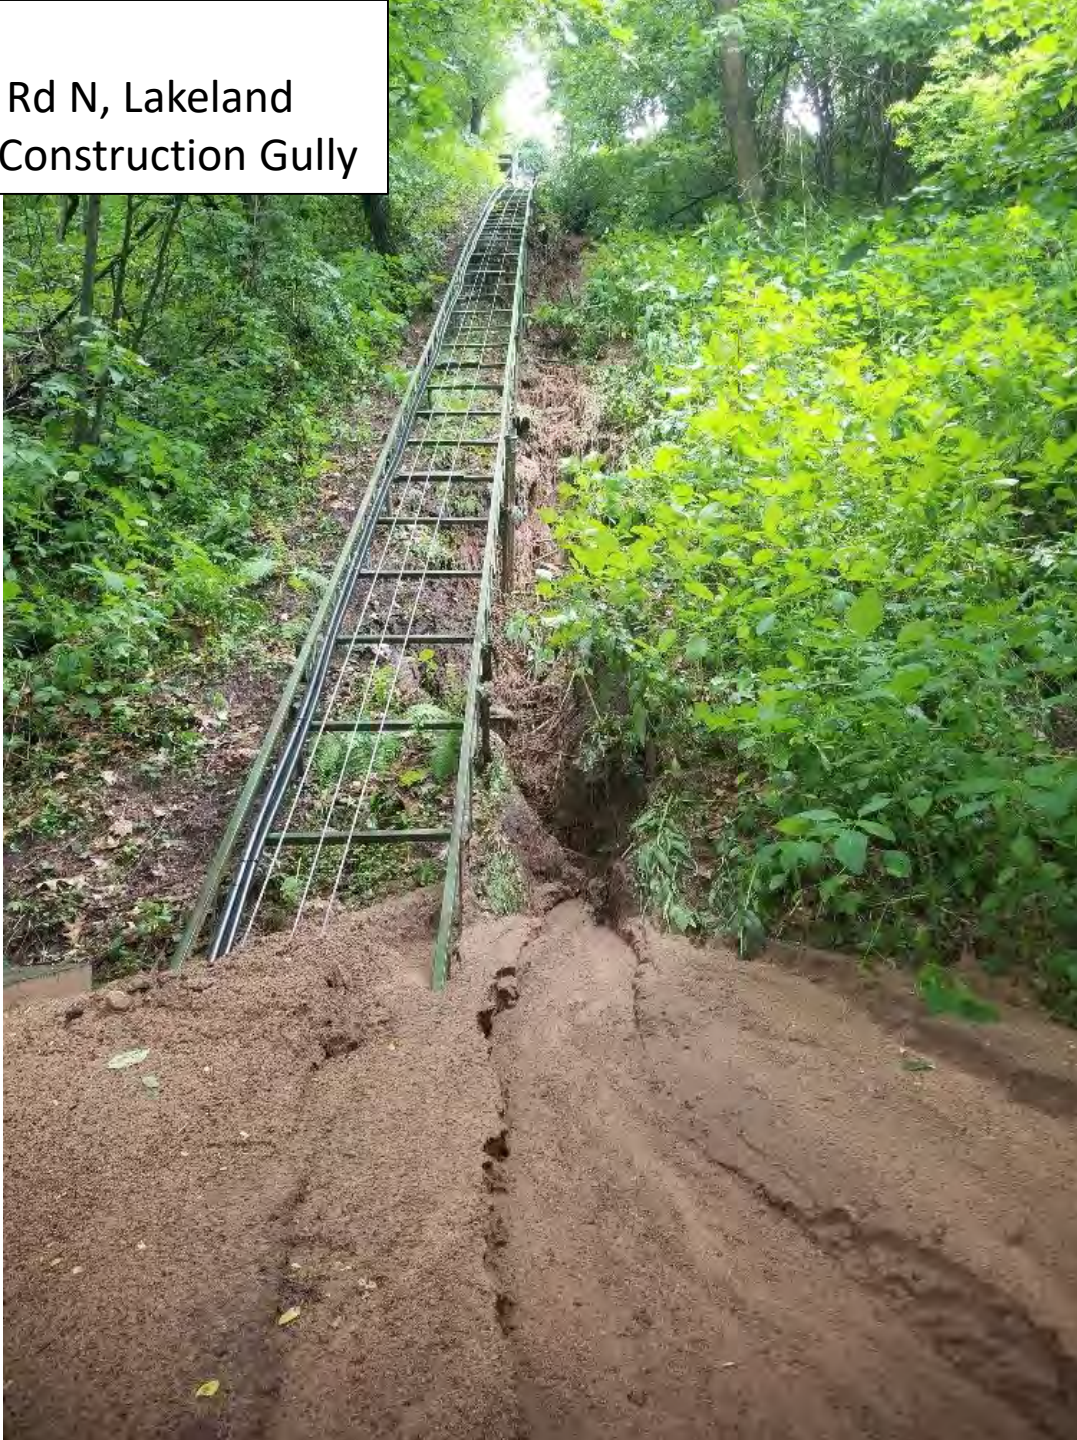
6/30/2020
1635 Rivercrest Rd N, Lakeland
Stordahl Home Construction Gully

Approx 40 ft

Approx 2 ft deep

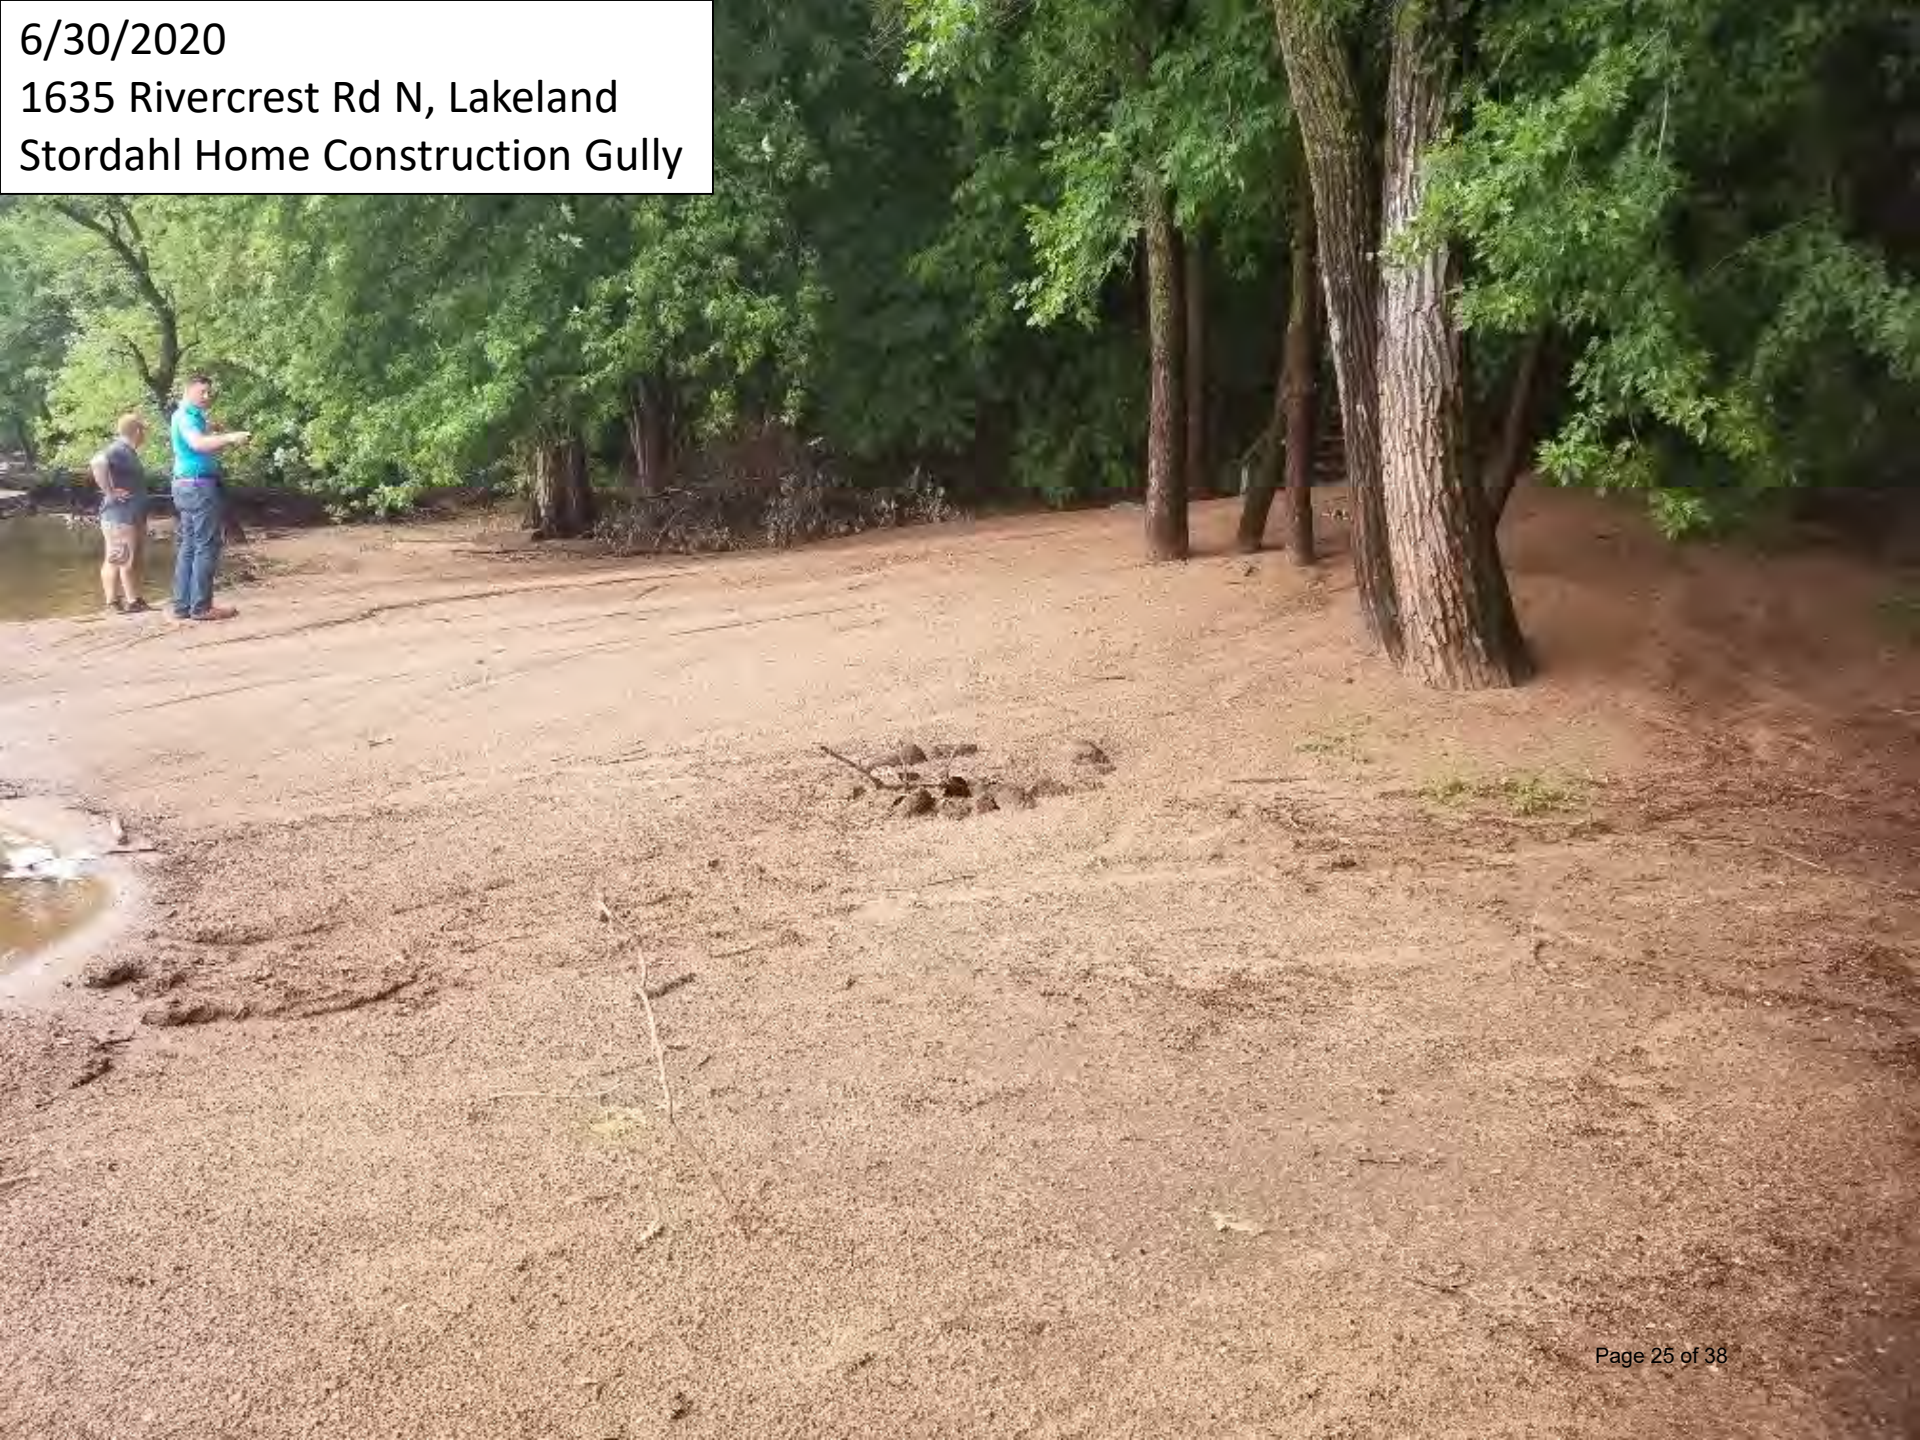
6/30/2020
1635 Rivercrest Rd N, Lakeland
Stordahl Home Construction Gully

Approx 45 ft

Approx 50 ft

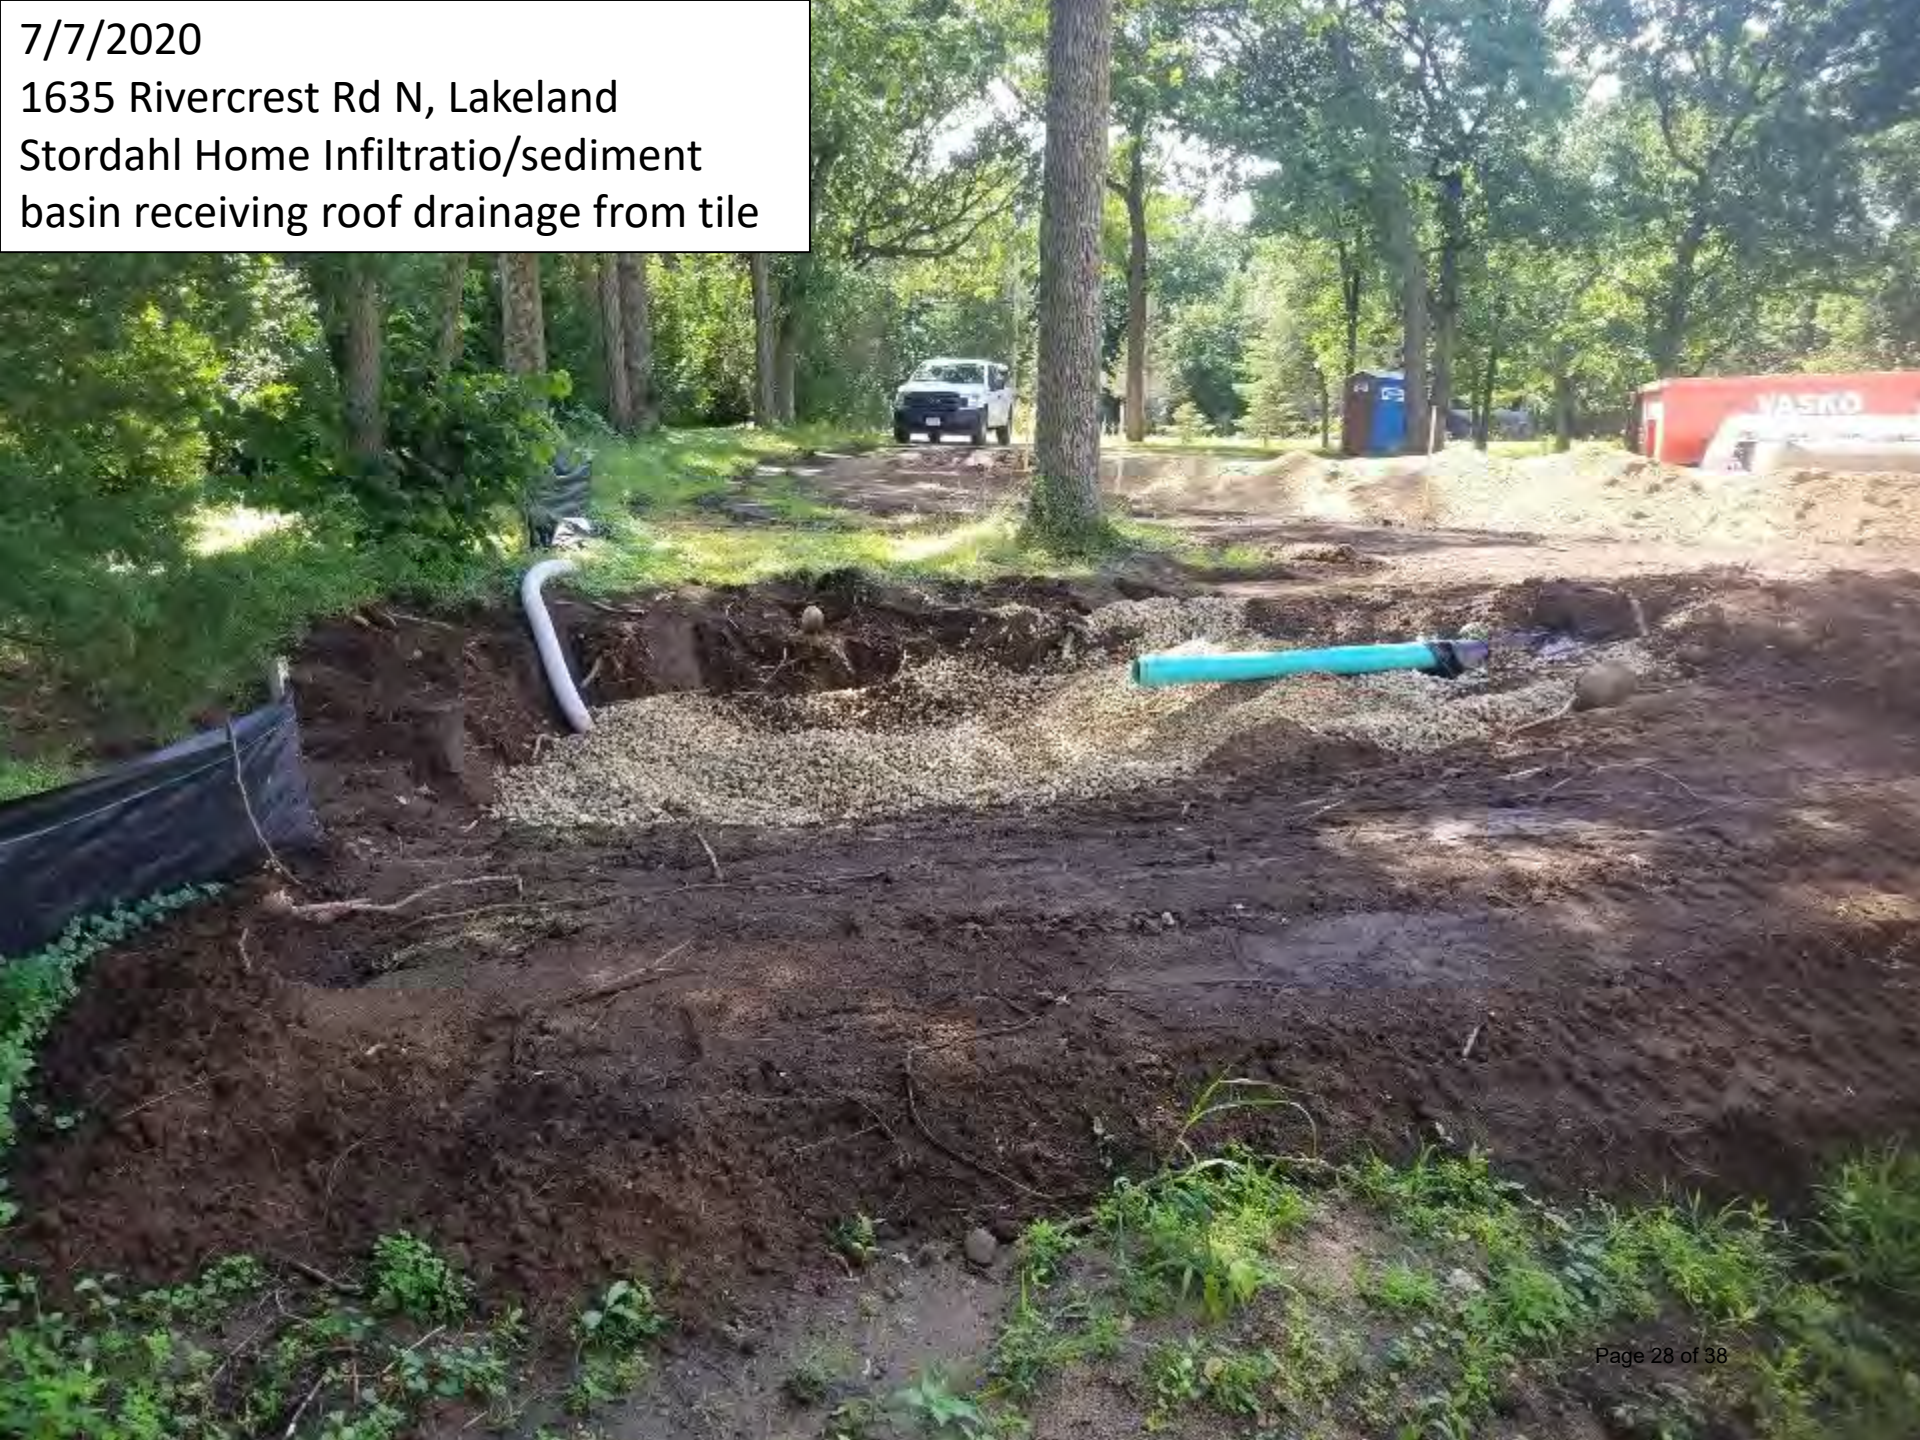
7/7/2020
1635 Rivercrest Rd N, Lakeland
Stordahl Home Infiltratio/sediment
basin receiving roof drainage from tile

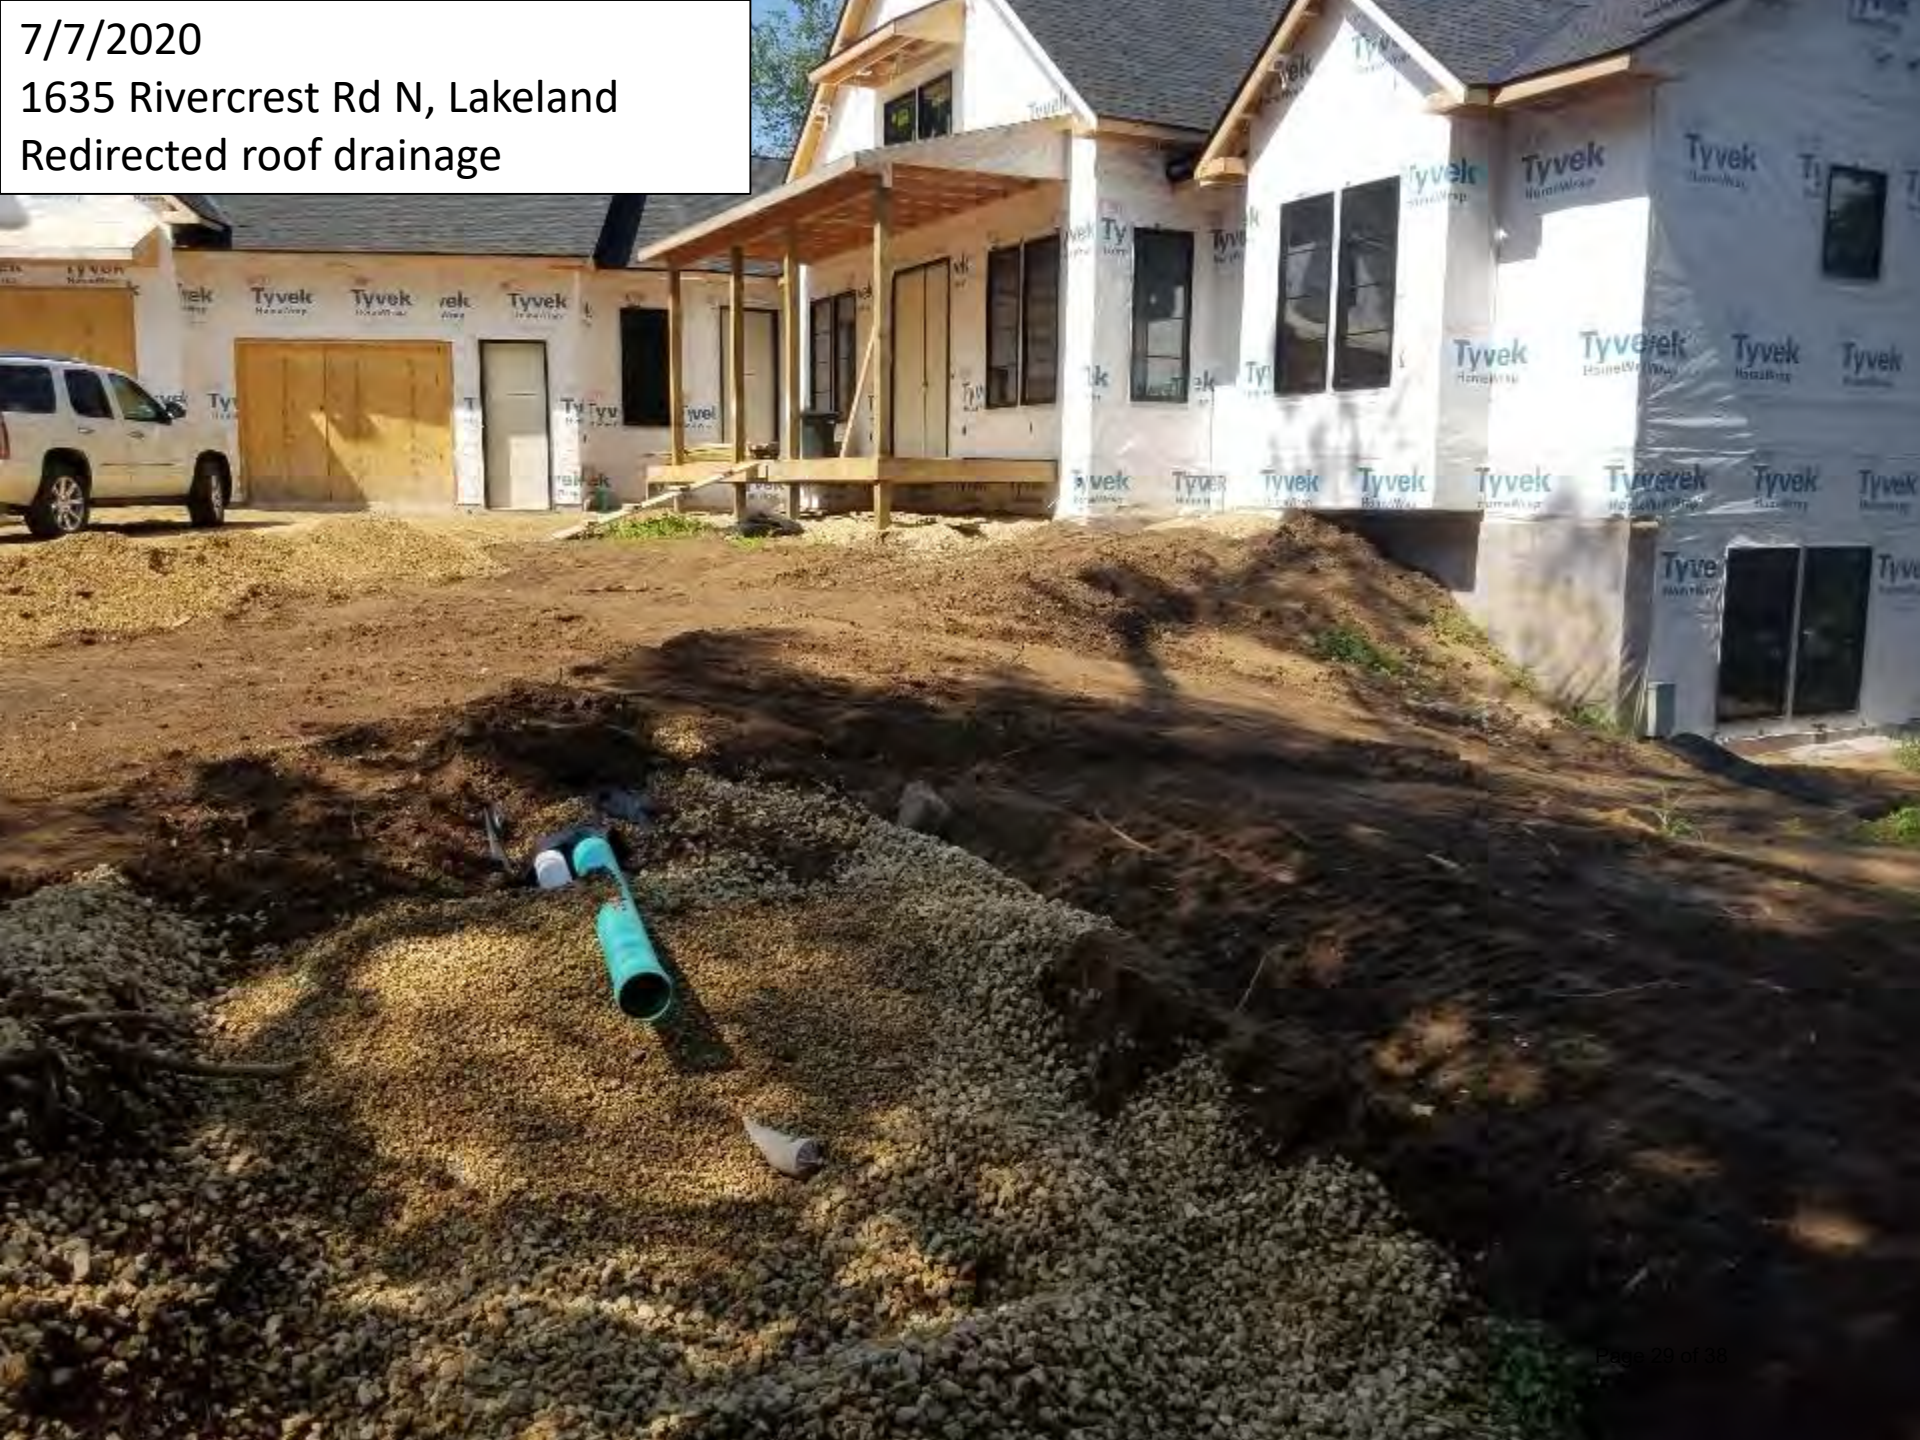
7/7/2020
1635 Rivercrest Rd N, Lakeland
Redirected roof drainage
