# MIDDLE ST. CROIX WATERSHED MANAGEMENT ORGANIZATION

## Regular Meeting of the Middle St. Croix Watershed Management Organization HELD REMOTELY DUE TO COVID -19 PANDEMIC

Thursday, May 14<sup>th</sup>, 2020

# Middle St. Croix Watershed Management Organization 2019 Water Monitoring Summary

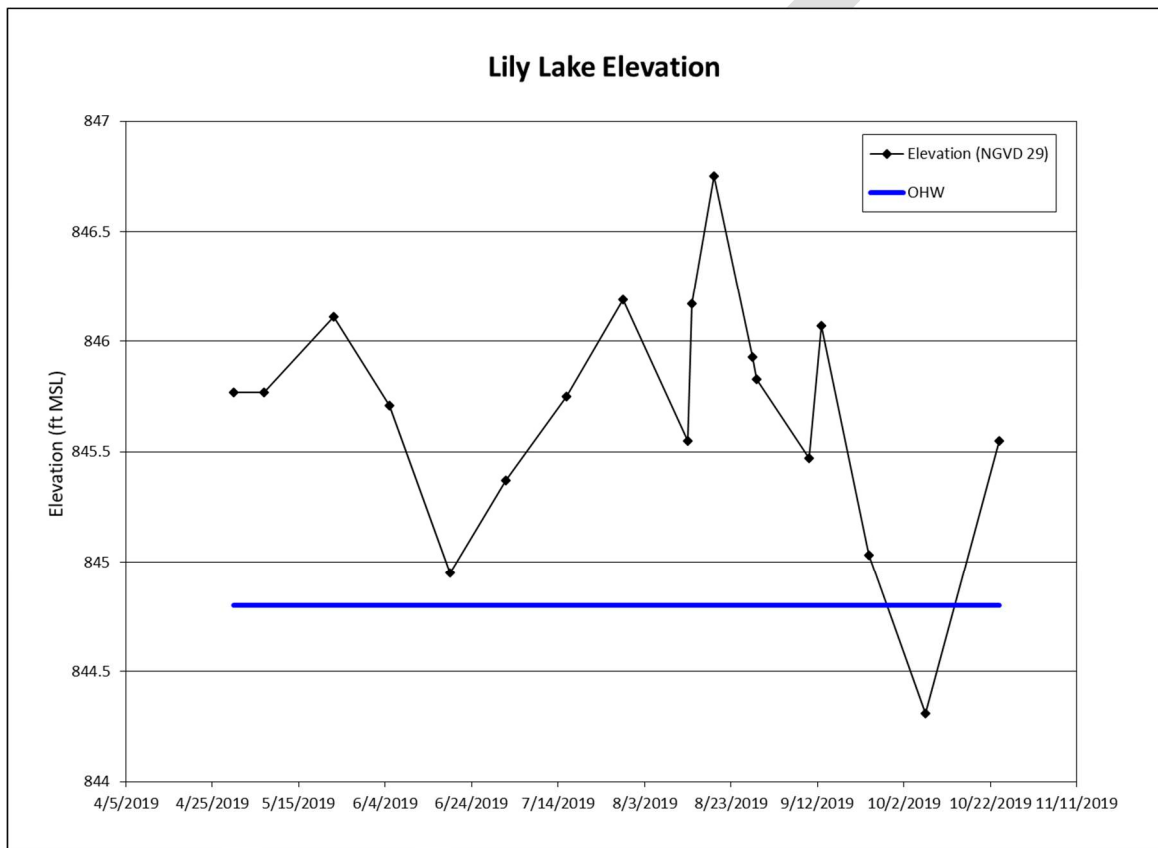
**Figure 2. Lily Lake 2019 Elevations**

Water elevation monitoring was conducted on two lakes, McKusick and Lily, from April to October 2019. Lake elevation readings are compared to the lake's Ordinary High Water level (OHW)<sup>1</sup>. The OHW for Lily and McKusick Lakes are 844.8 ft. and 851.7 ft., respectively. Changes in lake water elevation are often attributed to the changes in precipitation. The highest recorded elevation in 2019 for Lily Lake occurred on 8/19/2019 at 846.75 ft. and on 5/23/2019 at 855.01 ft. for McKusick Lake. Complete lake elevation data for 2019 can be found in Figure 2 and Figure 3. For historical lake elevations, visit the MN DNR Lake Finder webpage at <http://www.dnr.state.mn.us/lakefind/index.html>.

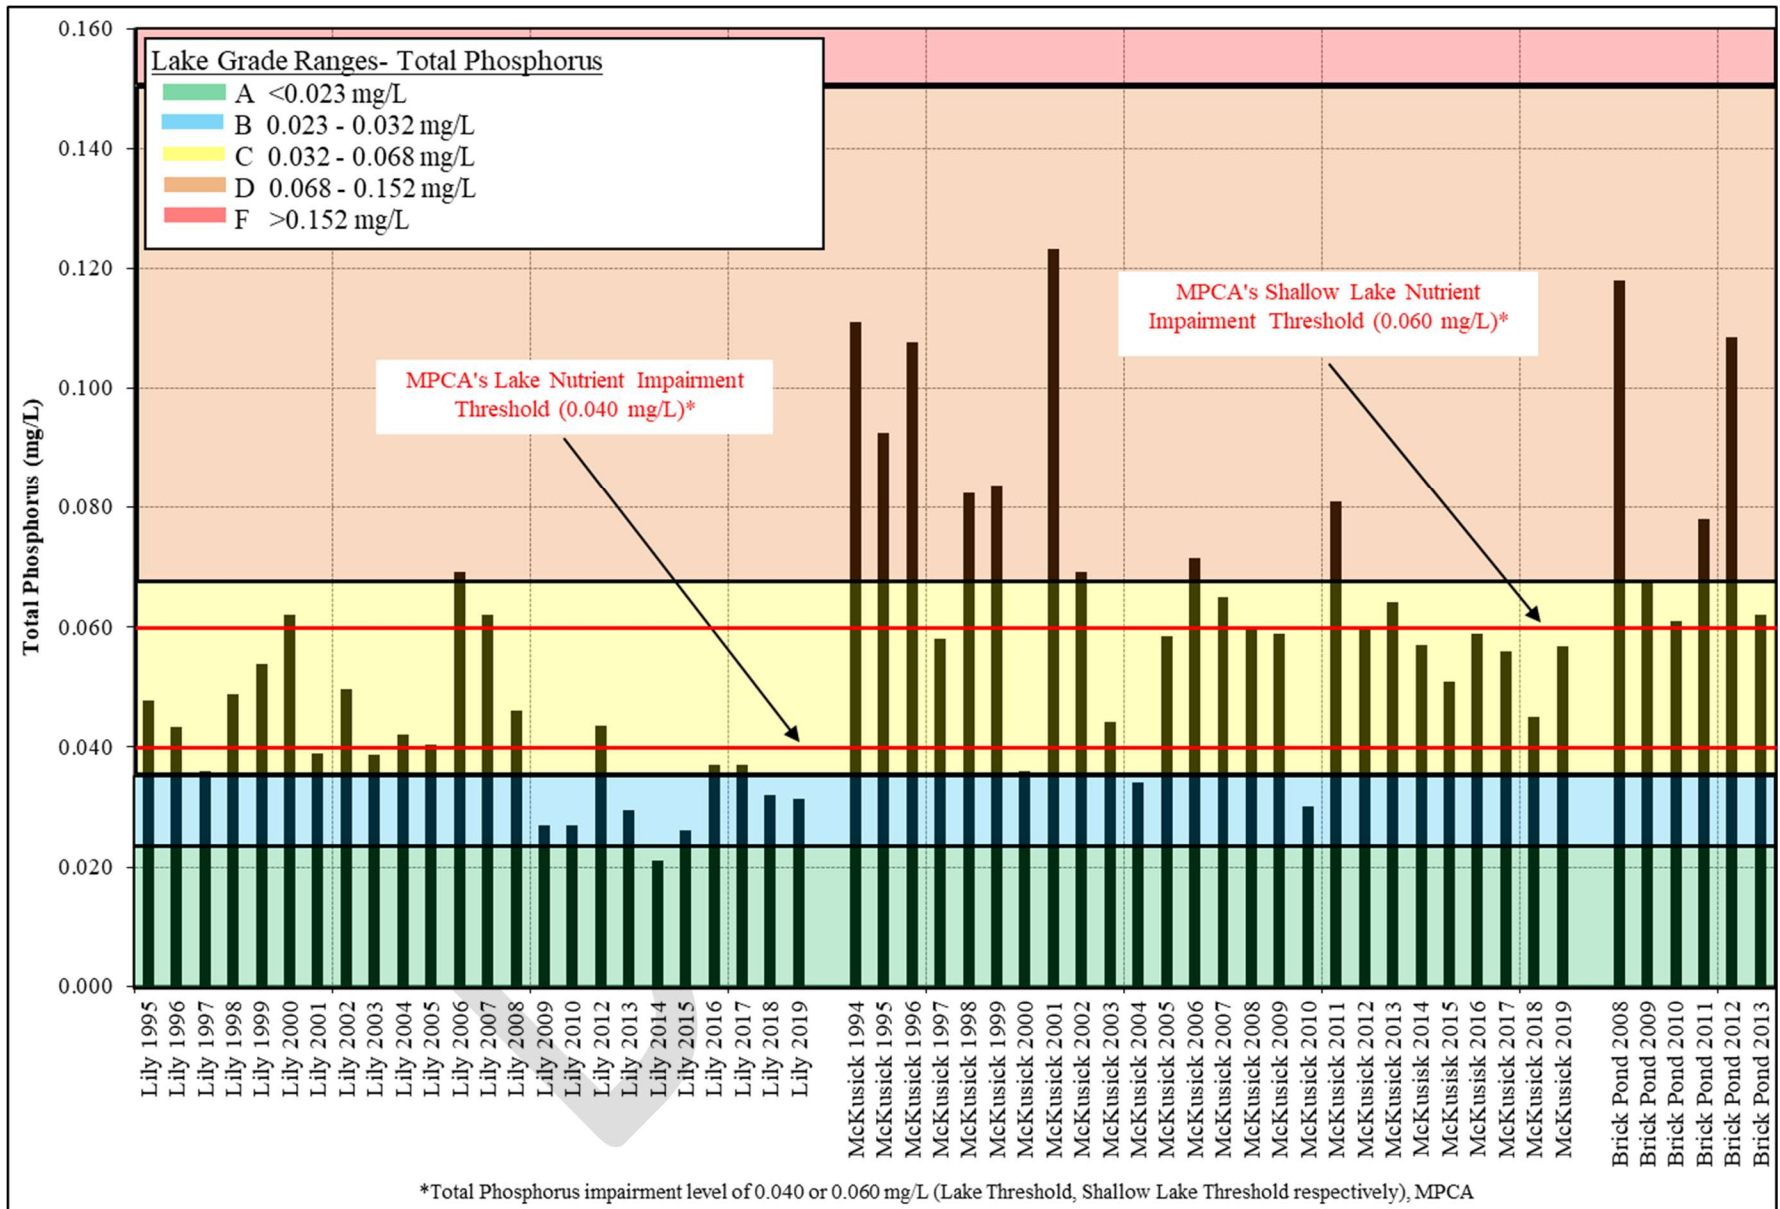
**Figure 4. MSCWMO Historic Summer Average Total Phosphorus**

Total phosphorus is analyzed as it is a major nutrient involved in the eutrophication of lakes and is generally associated with the growth of aquatic plants and/or algal blooms. Common sources of phosphorus include runoff from agricultural fields, livestock areas, urban areas, lakeshore lawns, and improperly operating septic systems. With most lakes in this region, phosphorus is the least available nutrient; therefore, its abundance, or scarcity, controls the extent of algal growth. Excess algal growth, in turn, negatively affects the clarity, or transparency, and ability of light to penetrate the water. The MPCA sets lake eutrophication standards for aquatic life and recreation. The standard for TP is 0.040 mg/L for deep lakes and 0.060 mg/L for shallow lakes. In general, shallow lakes are defined as less than 15 feet deep, with greater than 80% littoral area, and less than 10 acres. The 2019 summer average of TP values of MSCWMO lakes can be found in Figure 4.

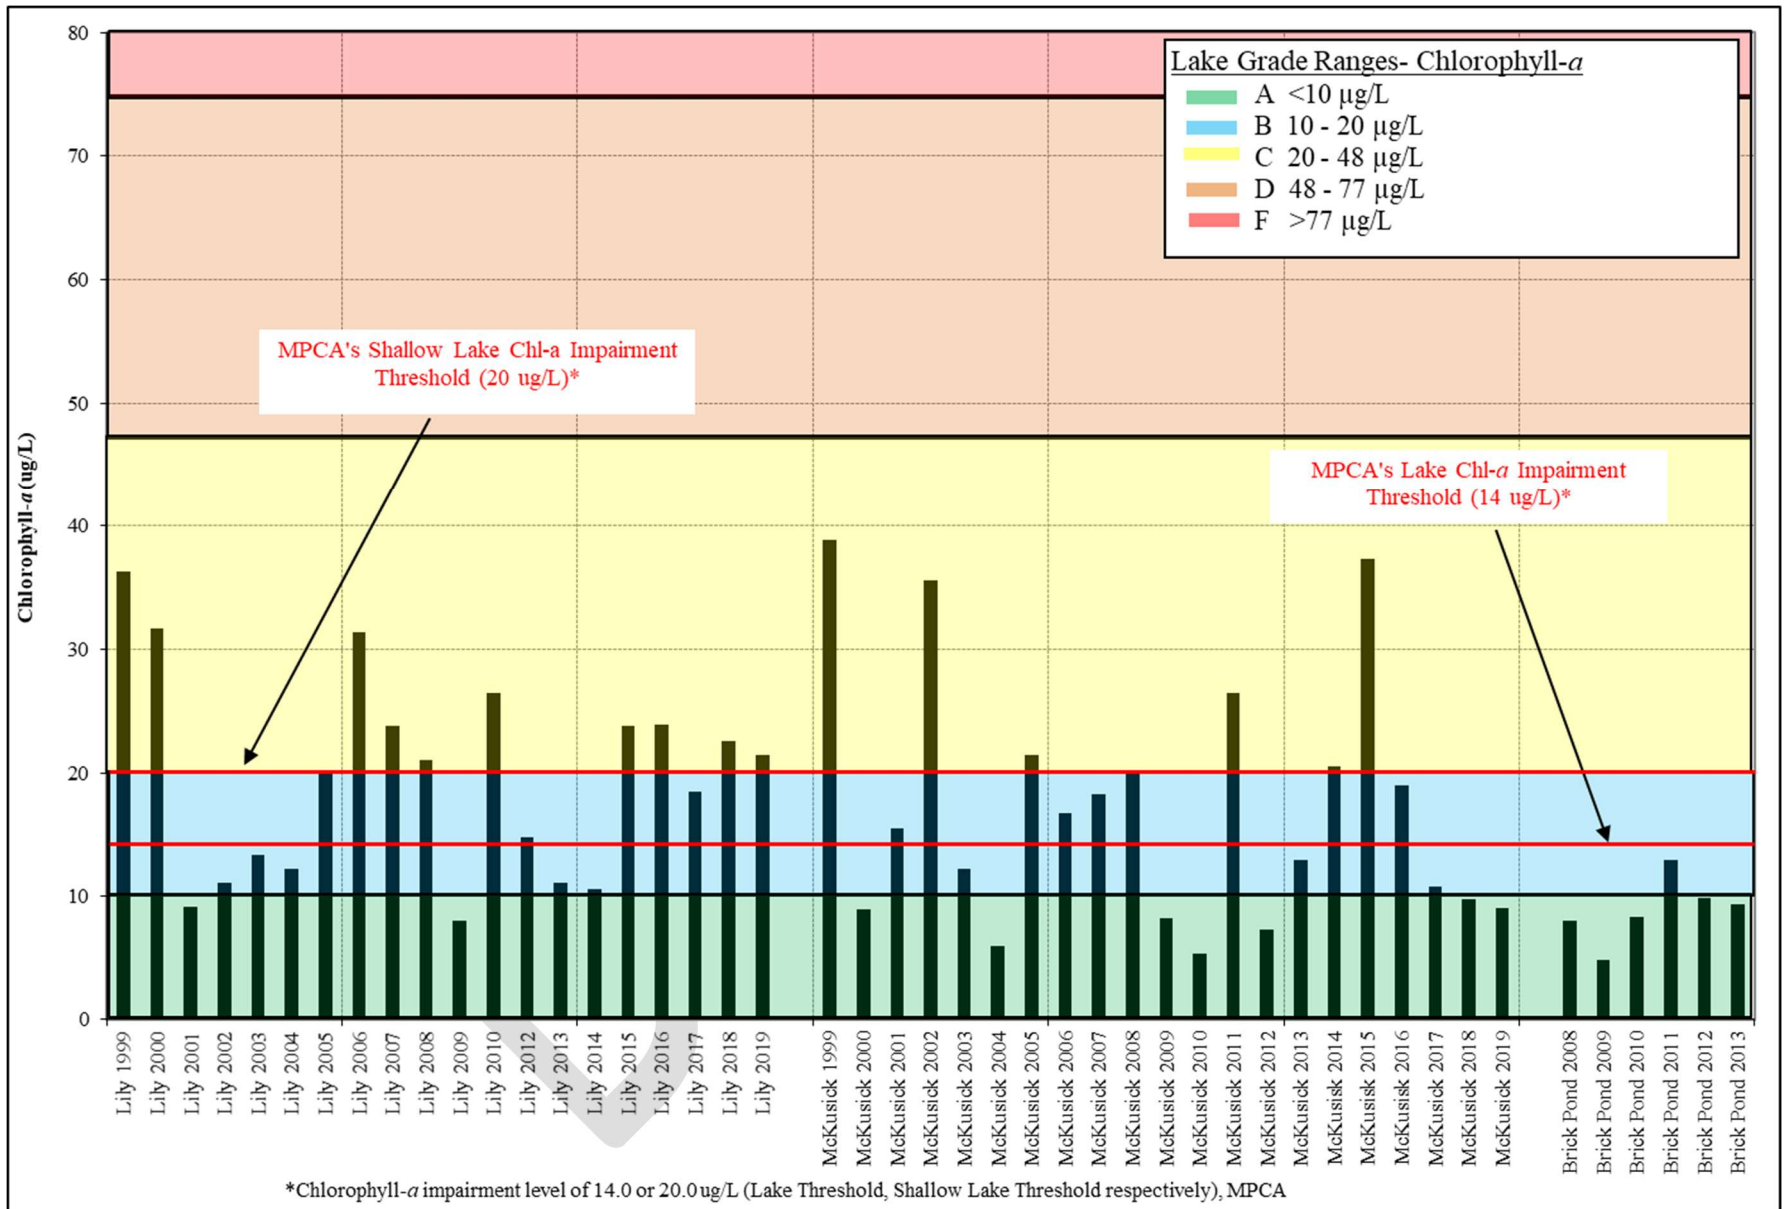
**Figure 5. MSCWMO Historic Summer Average Chlorophyll-*a***

Chlorophyll- $\alpha$  is measured as it is the photosynthetic component found in algae and aquatic plants and is an indicator of algal productivity. The MPCA standard for pheophytin-corrected

chl- $\alpha$  is 14  $\mu\text{g/L}$  for deep lakes and 20  $\mu\text{g/L}$  for shallow lakes. The 2019 summer average chl- $\alpha$  concentrations of MSCWMO lakes can be found in Figure 5.

concentration of 9.1  $\mu\text{g/L}$ ; lower than the chl- $\alpha$  average of 9.8  $\mu\text{g/L}$  from 2018 (Figure 5). None of the nine summertime samples collected in 2019 exceeded the MPCA shallow lake standard for chl- $\alpha$ . The average summertime TKN concentration for 2019 was 0.71 mg/L; lower than the 0.78 mg/L measured in 2018 (Figure 6). The 2019 summertime average water transparency measured by Secchi disk was 1.69 meters (Figure 7). Five of the nine summertime Secchi disk readings in 2019 were worse than the MPCA shallow lake impairment standard. McKusick Lake received a grade of a B- in 2019, an improvement from the C+ it received from 2016 to 2018. Temperature and DO profiles indicate that McKusick Lake exhibited thermal stratification during the summer months in the deepest portion of the lake with the thermocline around 3 meters. A majority of McKusick Lake is very shallow and does not stratify, and therefore is likely to have mixed throughout the summer. The elevation of McKusick Lake remained above the OHW for the entire monitoring season, reaching its highest recorded level of the season on 5/23/2019 with a level of 855.01 ft. and the lowest recorded level of the season occurred on 6/19/2019 with an elevation of 854.69 ft. (Figure 3). A summary of all lake results is presented in APPENDIX A.

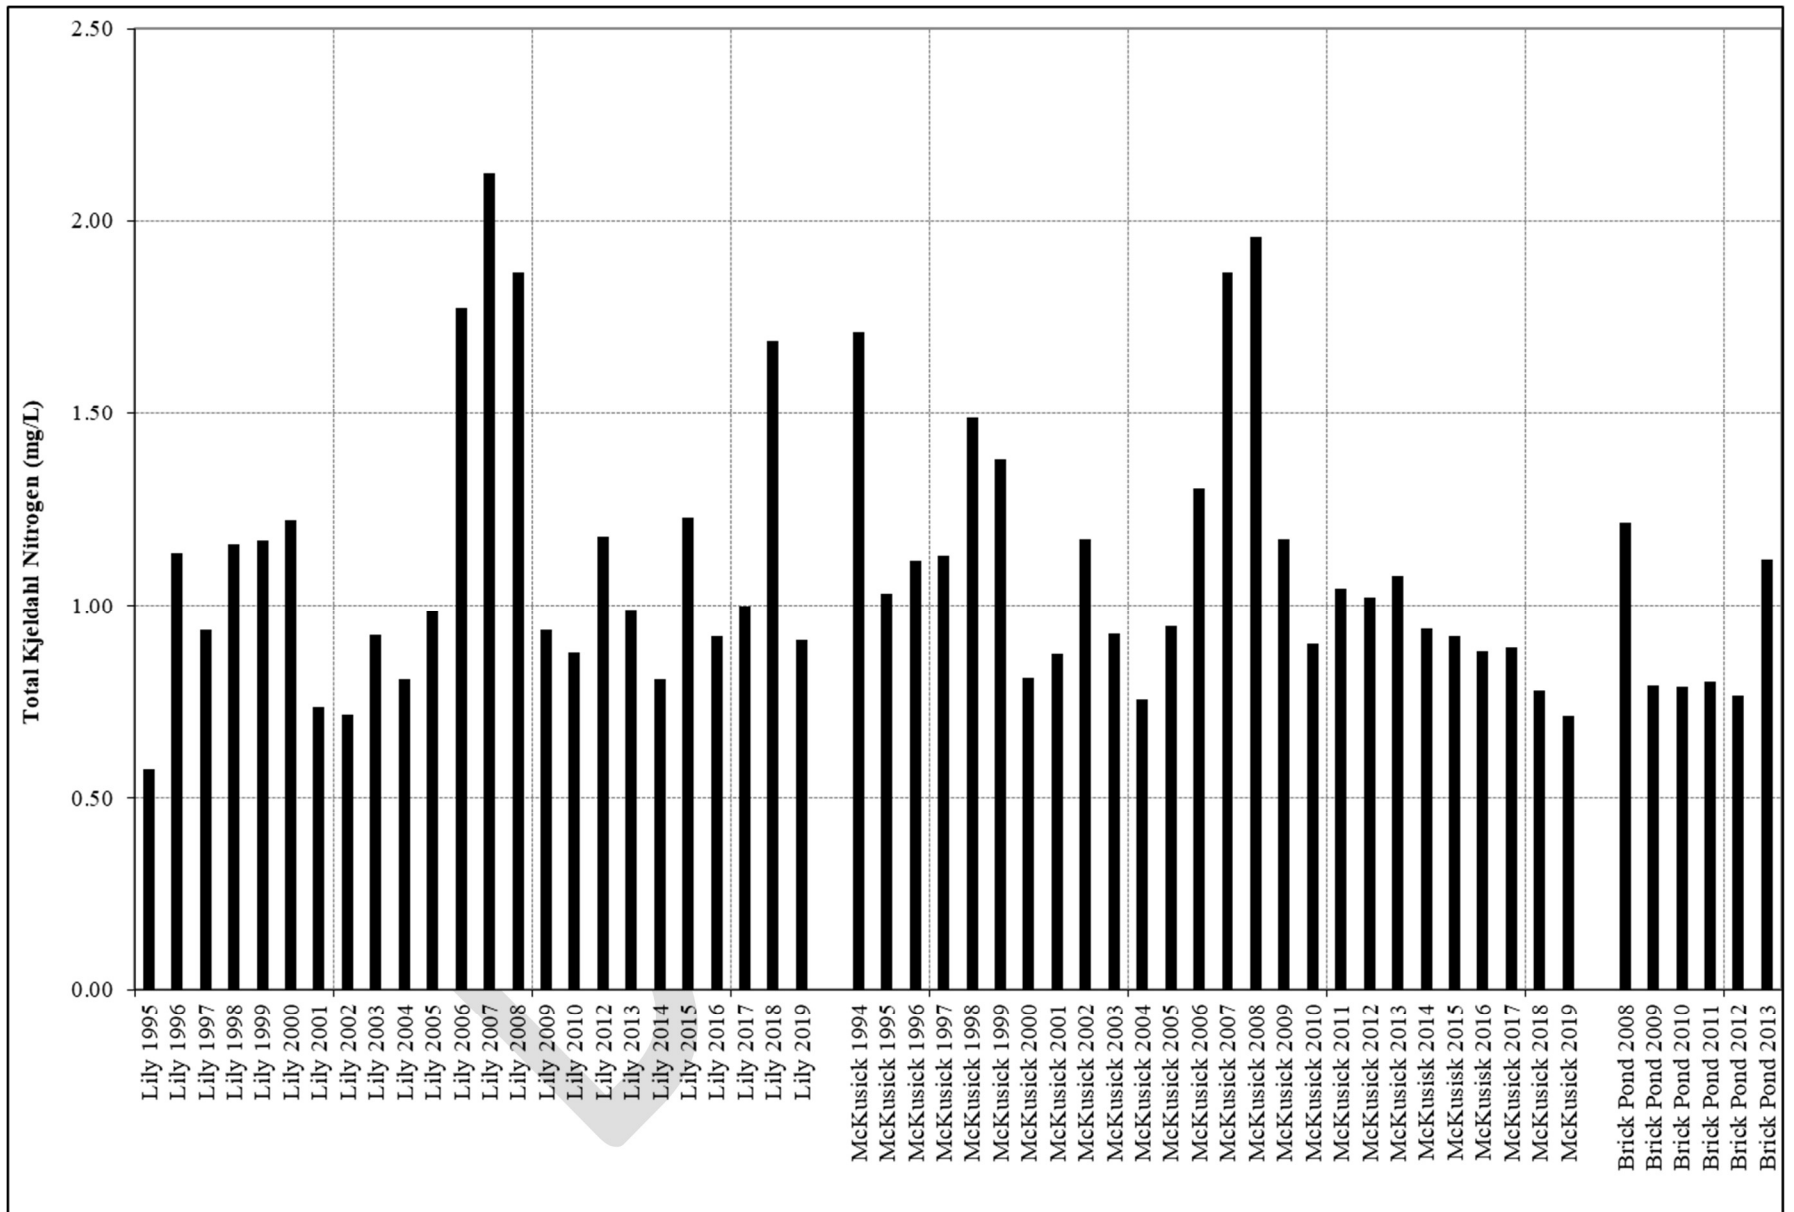
Figure 6. MSCWMO Historic Summer Average Total Kjeldahl Nitrogen

TKN, the sum of organic nitrogen and ammonia, was analyzed in MSCWMO lakes. While no standard exists for TKN because TP is often the limiting nutrient, TKN can contribute to eutrophication. The 2019 summer average TKN concentrations of MSCWMO lakes can be found in Figure 6.

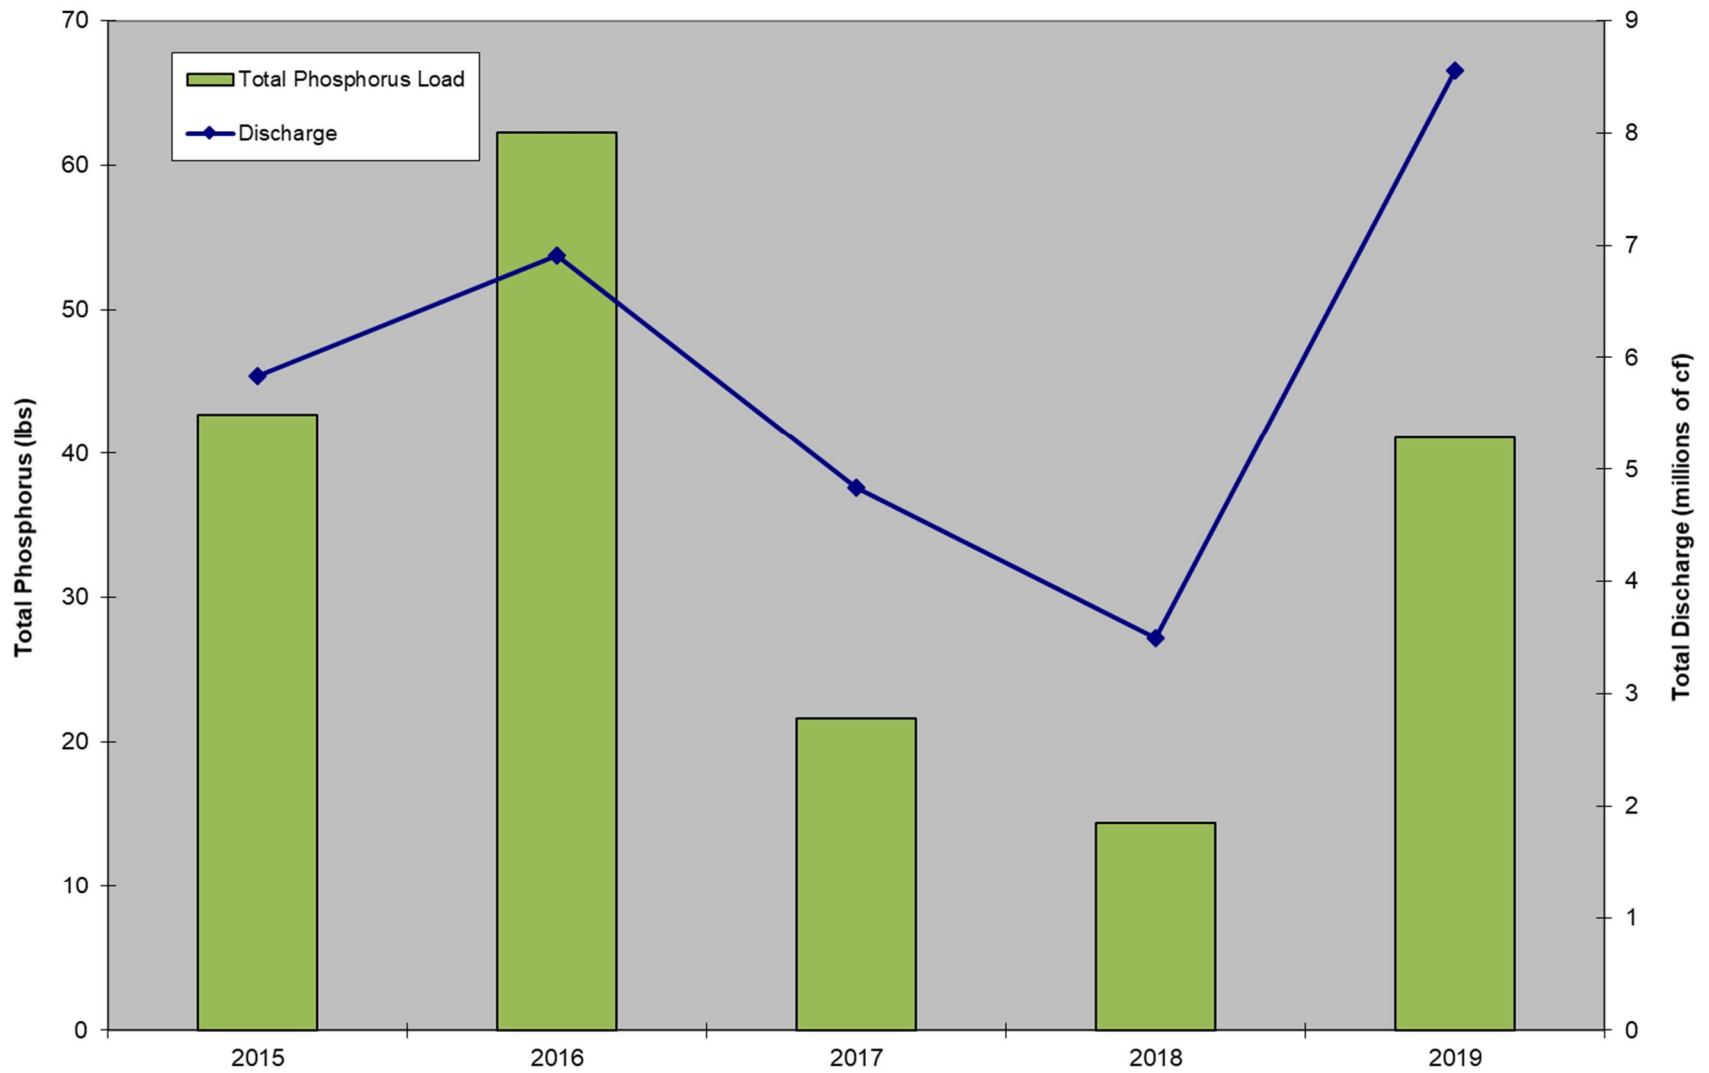
**Figure 8. Greeley Street Annual Discharge and Total Phosphorus Load**

The phosphorus load from the Greeley Street catchment appears to be discharge driven, with a majority of flow coming from direct street runoff and not through Brick Pond. This was again observed in 2019 with low base flow discharge, low average TP concentrations (0.077 mg/L), and low average TSS concentrations (2 mg/L). The only storm event sample collected had a TP result of 0.110 mg/L and TSS result of 8 mg/L. These results confirm the previous investigation in regards to the Greeley Street catchment having low sample results for TP and TSS during base flow and higher results during storm events. However, more storm samples should be collected to calculate more accurate TP and TSS loadings and to better characterize storm events.
