MIDDLE ST. CROIX WATERSHED MANAGEMENT ORGANIZATION

Regular Meeting of the Middle St. Croix Watershed Management Organization HELD REMOTELY DUE TO COVID -19 PANDEMIC

Thursday, May 13th, 2021

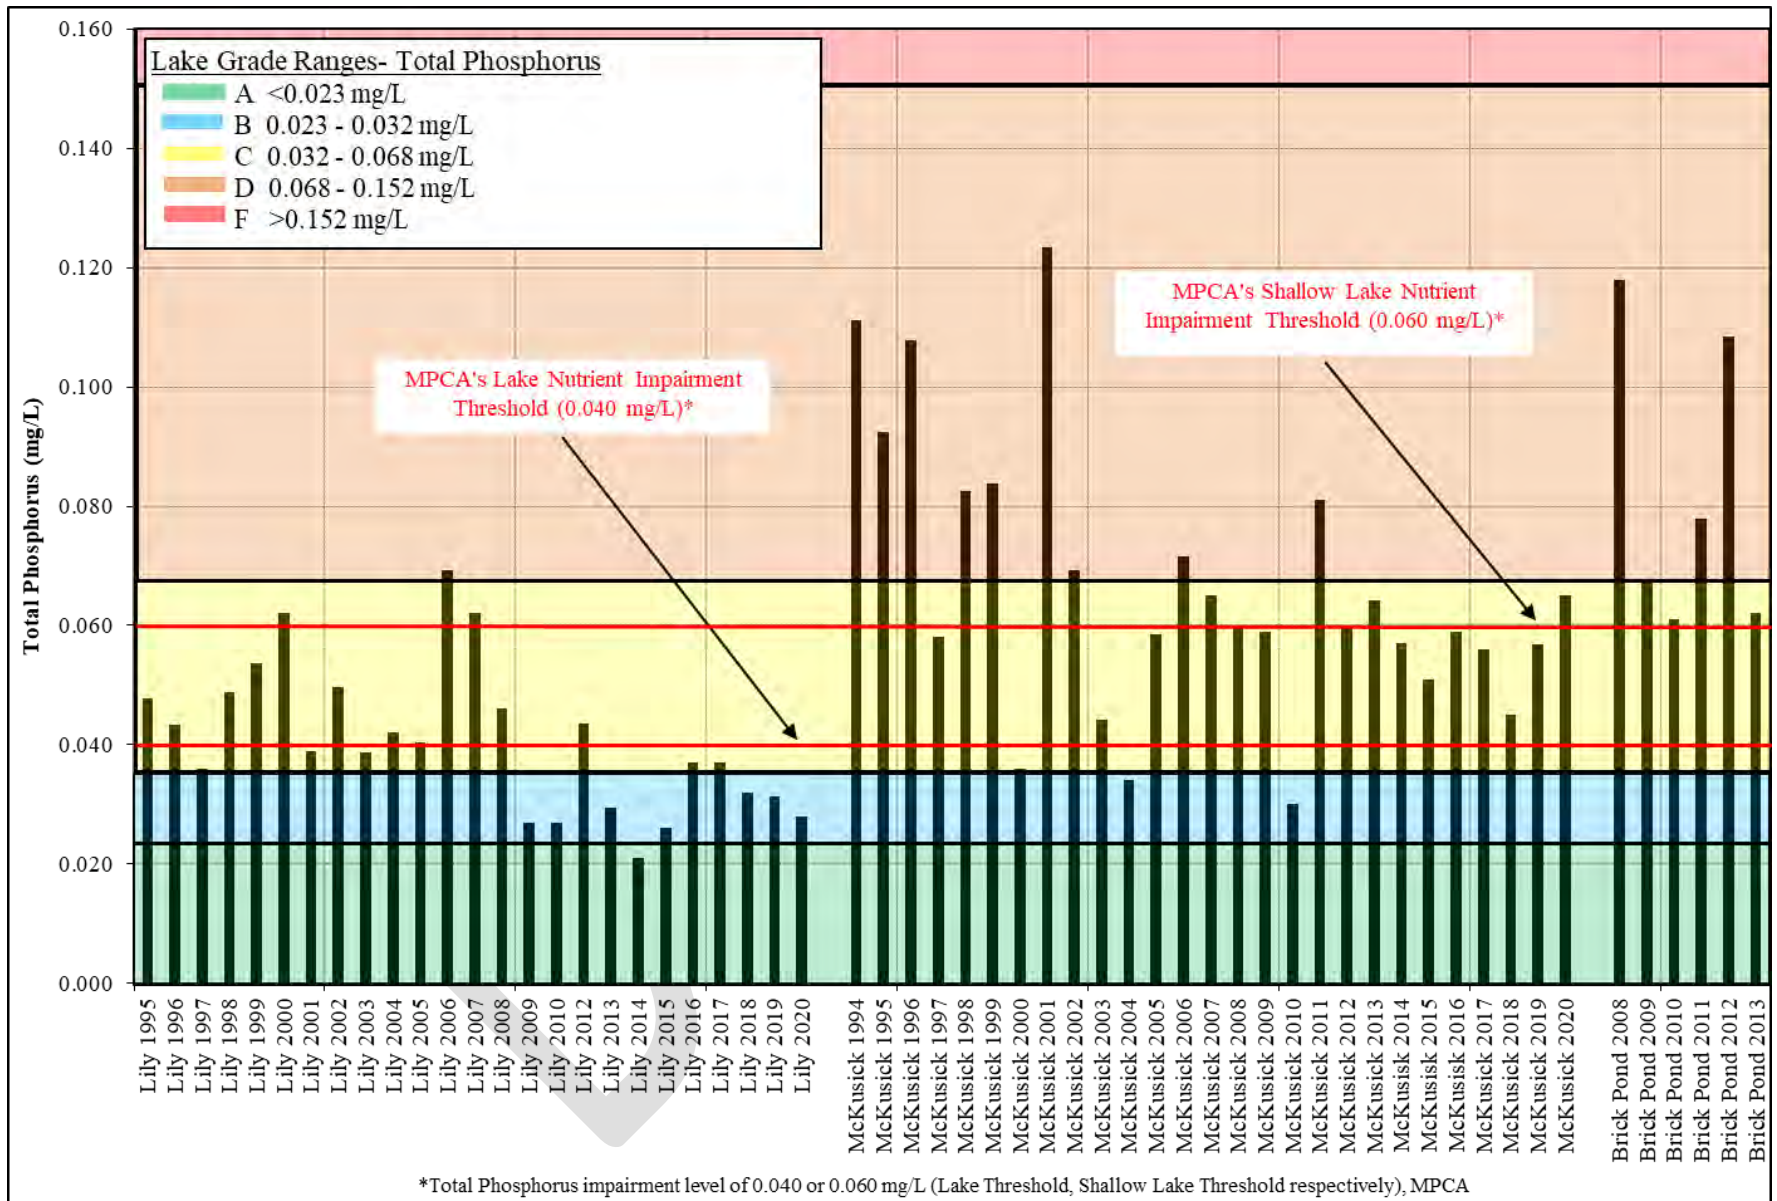
Figure 2. MSCWMO Historic Summer Average Total Phosphorus

Total phosphorus is analyzed as it is a major nutrient involved in the eutrophication of lakes and is generally associated with the growth of aquatic plants and/or algal blooms. Common sources of phosphorus include runoff from agricultural fields, livestock areas, urban areas, lakeshore lawns, and improperly operating septic systems. With most lakes in this region, phosphorus is the least available nutrient; therefore, its abundance or scarcity controls the extent of algal growth. Excess algal growth, in turn, negatively affects the clarity, or transparency, and ability of light to penetrate the water. The MPCA sets lake eutrophication standards for aquatic life and recreation. The standard for TP is 0.040 mg/L for deep lakes and 0.060 mg/L for shallow lakes. In general, shallow lakes are defined as less than 15 feet deep, with greater than 80% littoral area, and less than 10 acres. The 2020 summer average of TP values of MSCWMO lakes can be found in Figure 2.

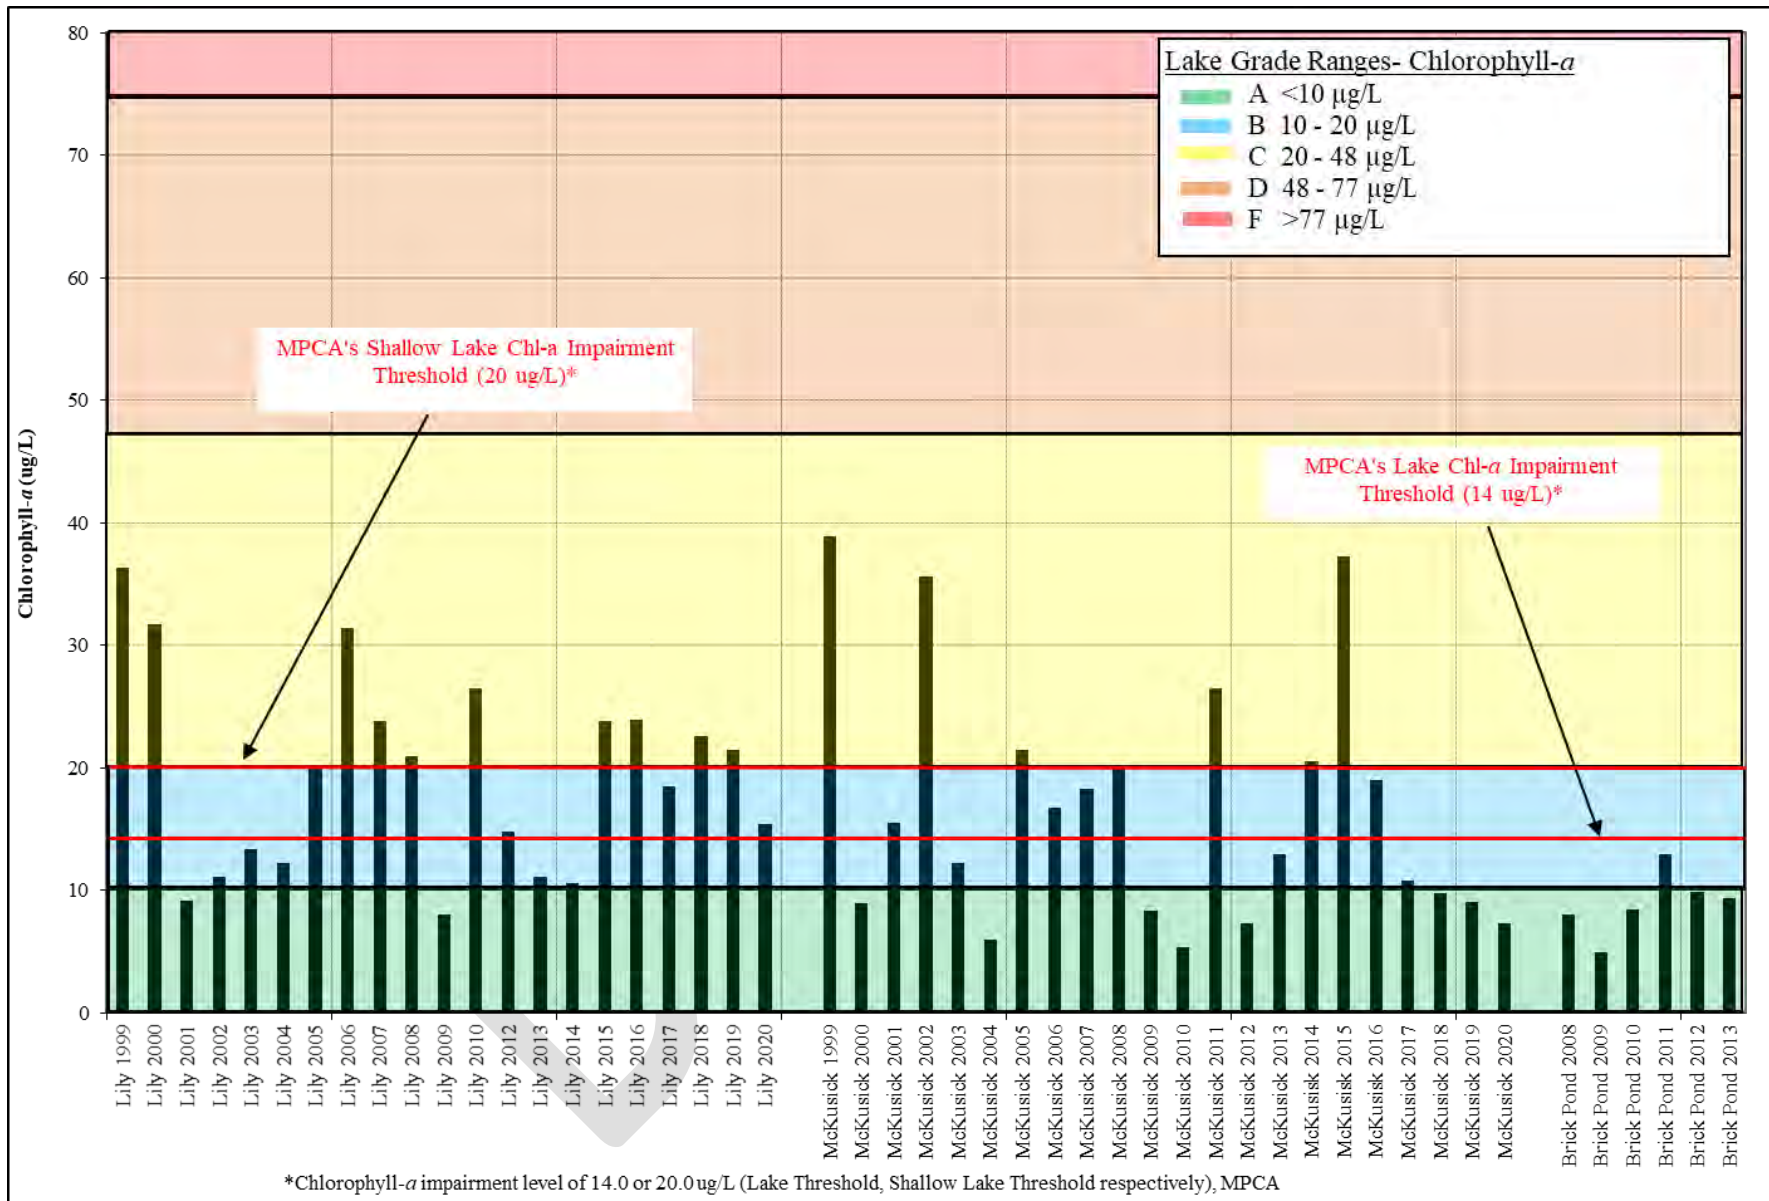
Figure 3. MSCWMO Historic Summer Average Chlorophyll-a

Chlorophyll- α is measured because it’s the photosynthetic component found in algae and aquatic plants and is an indicator of algal productivity. The MPCA standard for pheophytin-corrected

chl- α is 14 $\mu\text{g/L}$ for deep lakes and 20 $\mu\text{g/L}$ for shallow lakes. The 2020 summer average chl- α concentrations of MSCWMO lakes can be found in Figure 3.

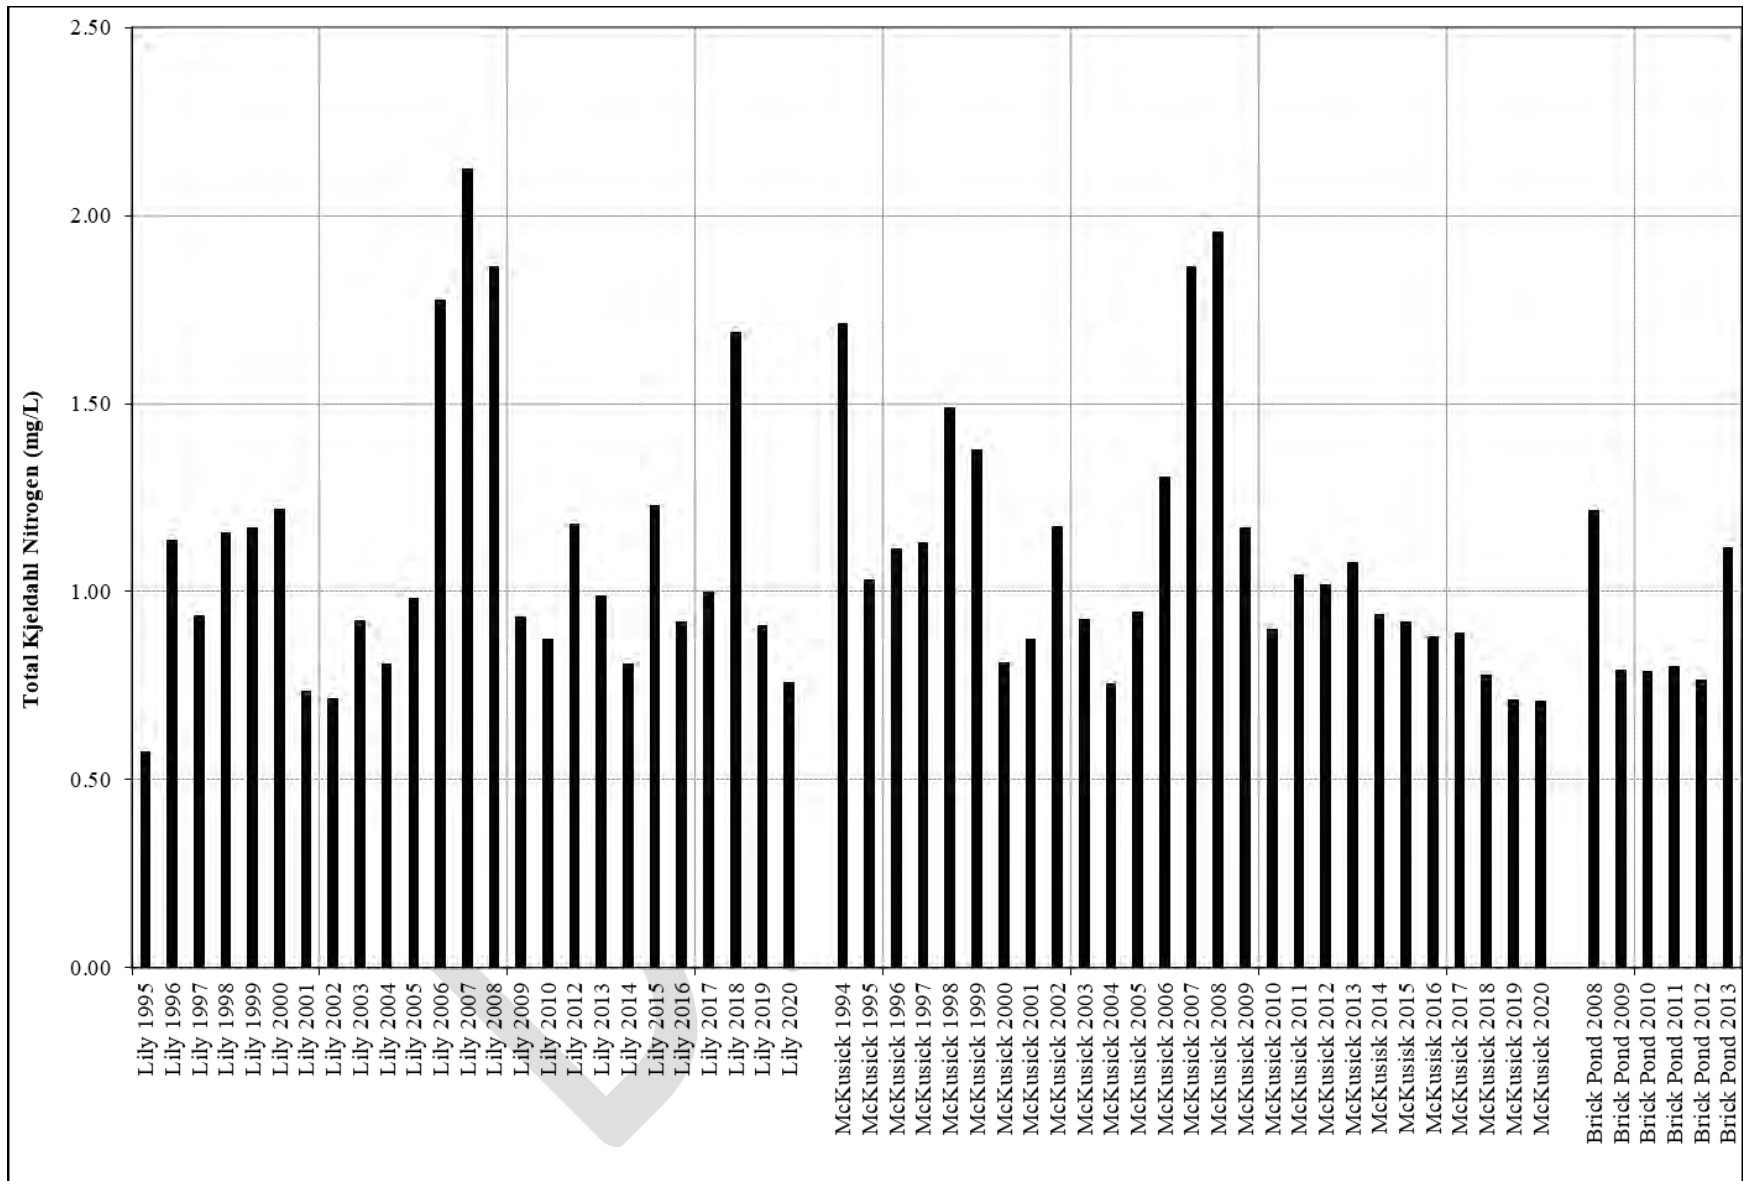
Figure 4. MSCWMO Historic Summer Average Total Kjeldahl Nitrogen

TKN, the sum of organic nitrogen and ammonia, was analyzed in MSCWMO lakes. While no standard exists for TKN because TP is often the limiting nutrient, TKN can contribute to eutrophication. The 2020 summer average TKN concentrations of MSCWMO lakes can be found in Figure 4.

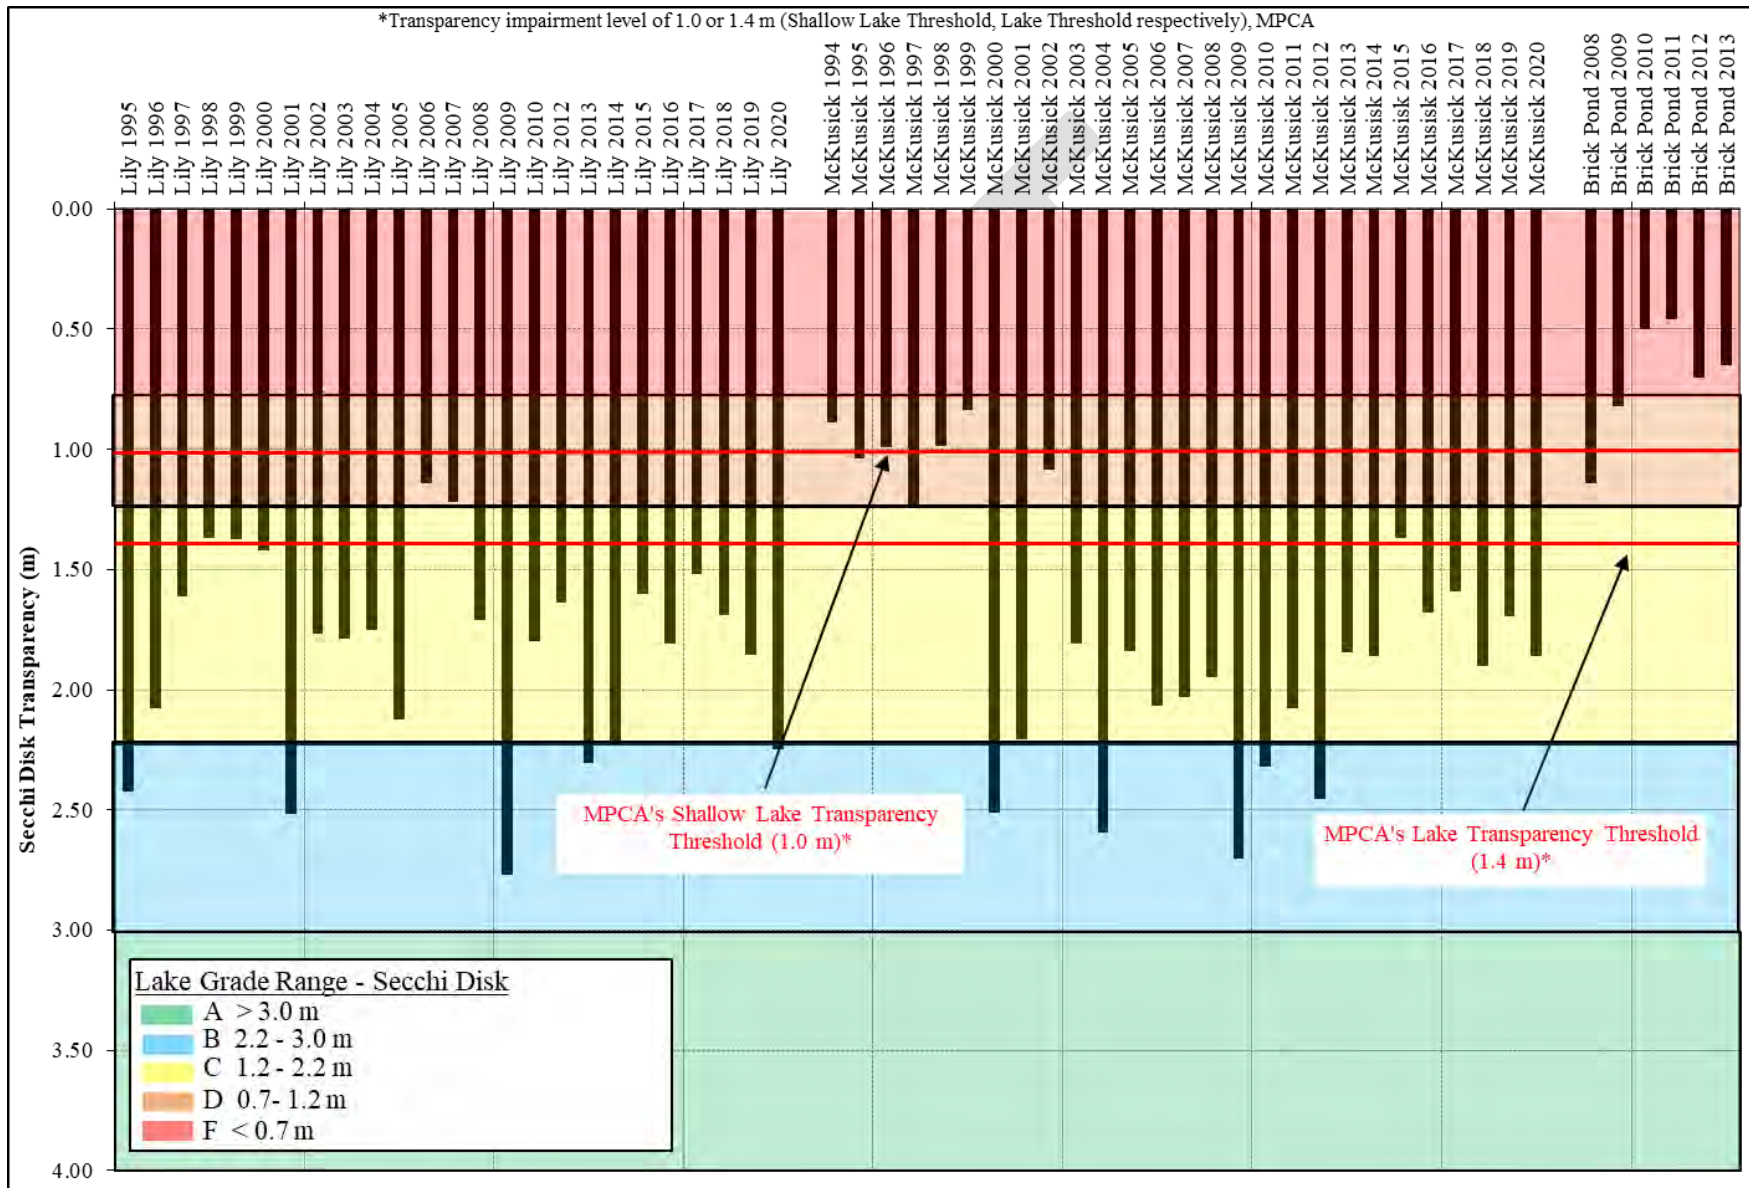
Figure 5. MSCWMO Historic Summer Average Secchi Disk Transparency

Field measurements are recorded while collecting lake samples, including Secchi disk transparency. The measurement of light penetration using a Secchi disk gives a simple measure of water transparency, or clarity. A reduction in water transparency is typically the result of turbidity composed of suspended sediments, organic matter and/or phytoplankton (algae). The MPCA standard for Secchi disk transparency is 1.4 meters for deep lakes and 1.0 meter for shallow lakes. The 2020 summer average transparency of MSCWMO lakes can be found in Figure 5.

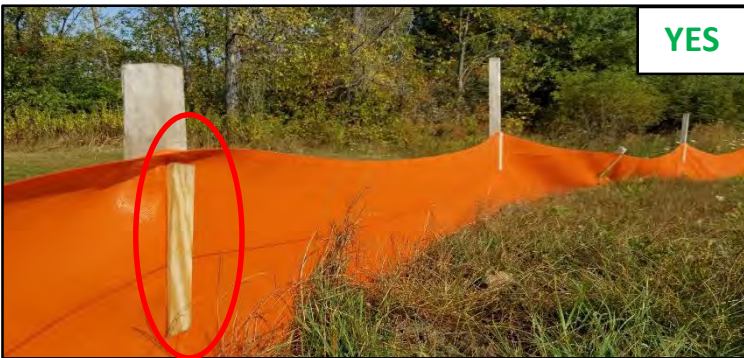
Fence **tight, trenched in**, secondary piece of lath used for reinforcement.

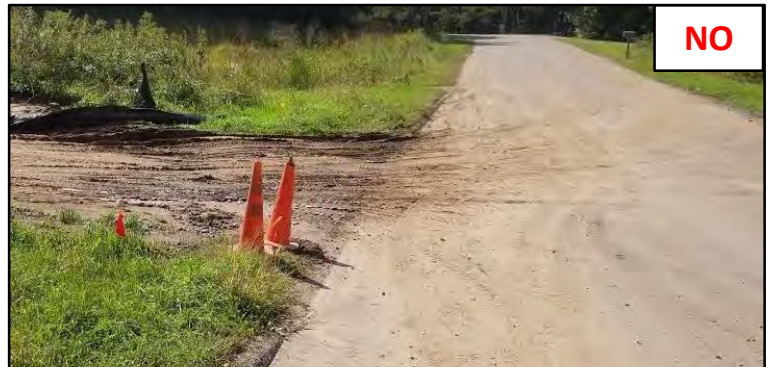
Mud and sediment tracked out into roadway. Sediments tracked out must be **swept daily**.

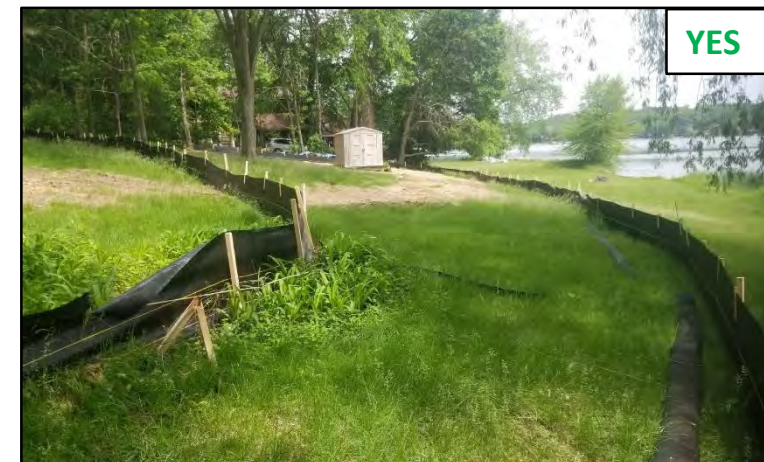
Double layer of silt fence with grass buffer next to Big Marine Lake.

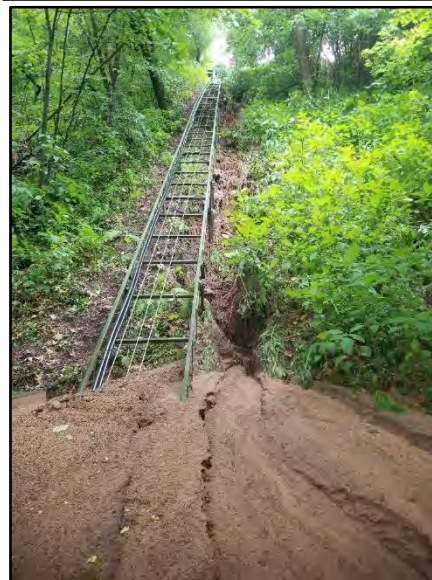
Don't let this happen on your site! Be mindful if working near the bluff! Even appropriate measures can fail in extreme rain or snowmelt. Always try to direct water away from bluffs and slopes, and avoid concentration of flow.
